Detecting and Preventing Future Aileron Cable Damage

Recommendations for Voluntary AD 2019-23-10 Follow-On Actions
ABS Air Safety Foundation

December 16, 2019

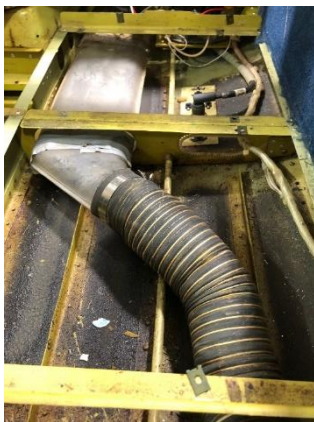
(left) Original duct

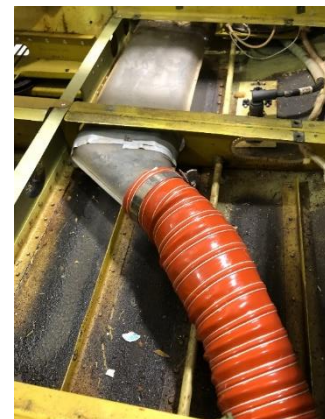
(right) New SCEET duct

Replace the original fiberglass-impregnated ducting with double-wall silicone SCEET ducting. SCEET aids in stopping some of the condensation that drips off the heater system, and therefore makes corrosion of the cable swaged ends beneath the duct less likely. SCEET may be purchased by the foot from several different aircraft supply chains. The ducting is 2 ½ inch in diameter. You will need to purchase two feet and then cut it to the correct length for your installation. The part number at **Aircraft Spruce** is **05-30610** and is called **Vena HTD flexible duct**.

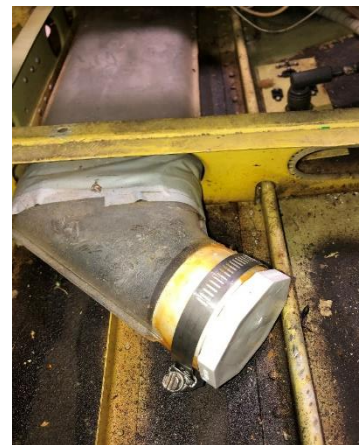
(right) Plug installed on aft heat plenum aft of the outlet for seats 3 and 4

If you do not require heat in the baggage area or aft cabin behind the 3rd and 4th seats, remove the original ducting completely. Install a 2" PVC plug (**Home Depot SKU 741 264**) inside the plenum to which the original duct is attached, then use a #36 stainless steel hose clamp (**Home Depot SKU 100 494**) to tighten the hose around the plug. The clamp and plug may also be purchased from any of the building supply stores. You will need to sand the plug's outer diameter down slightly to install it inside the flange with a tight fit.
