# Interim report

on the accident on **1<sup>st</sup> June 2009**  
to the **Airbus A330-203**  
registered **F-GZCP**  
operated by **Air France**  
**flight AF 447 Rio de Janeiro – Paris**

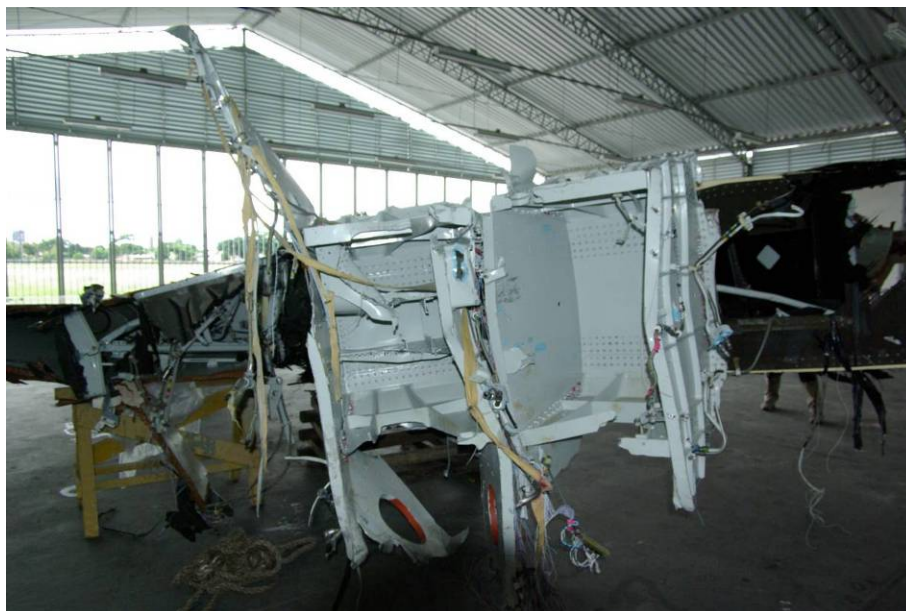
The tail fin was damaged during its recovery and transport but the photographs available made it possible to identify the damage that was not the result of the accident. The middle and rear fasteners with the related fragments of the fuselage hoop frames were present in the fin base. The distortions of the frames showed that they broke during a forward motion with a slight twisting component towards the left.

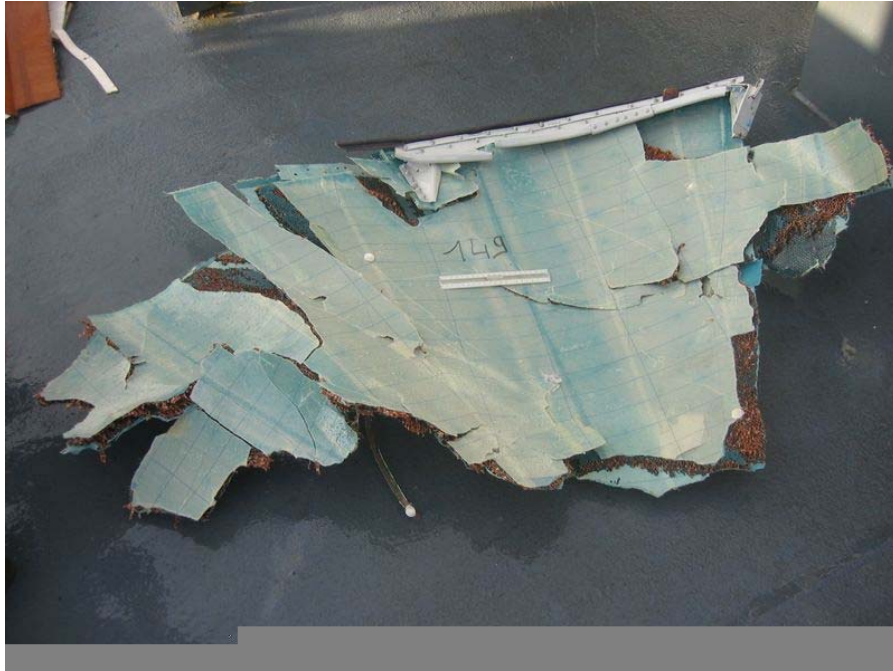
Part of the radome was found, representing approximately a fifth of its circumference along its upper part.

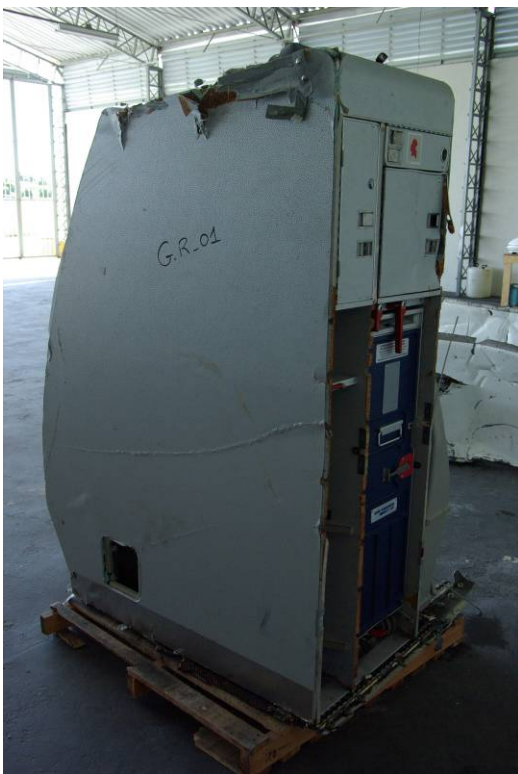
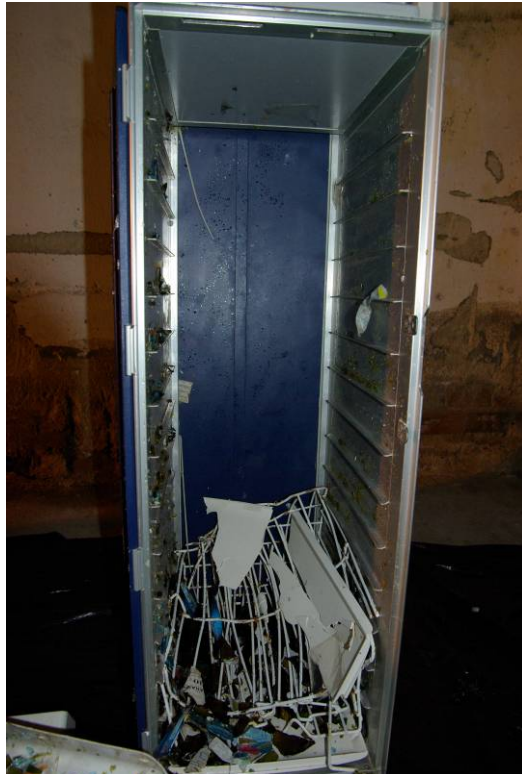
The galley, identified as G2, located at the level of door 2 on the right-hand side, was not very distorted. Baskets and racks were compressed in the lower part of both galley carts.

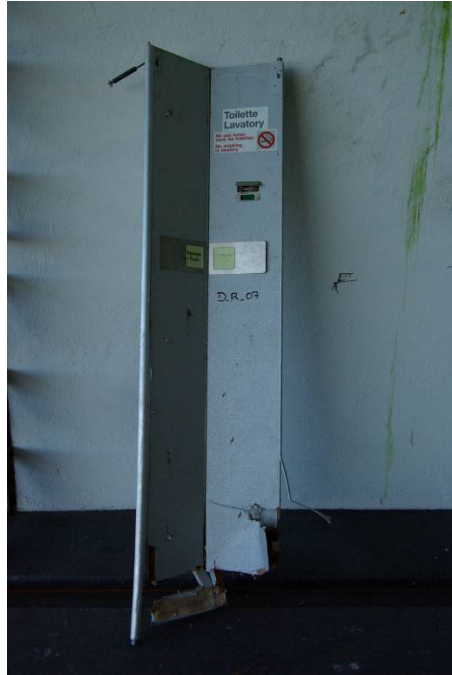
The distortions observed in the metal vertical reinforcements of a toilet door showed evidence of great compressive forces.

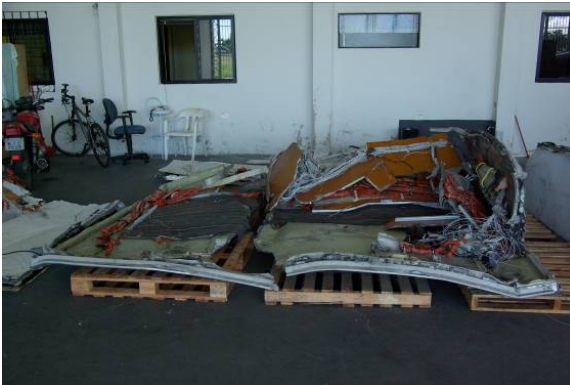
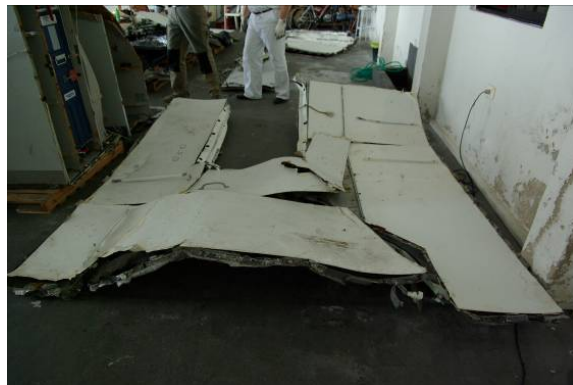
Fragments of the walls of the flight crew rest module were crumpled and those of the ceiling were deformed downwards. The floor was curved under the effect of a strong upward pressure from below. The connecting brackets between the floor and the walls were bent backwards.

Observations of the tail fin and on the parts from the passenger (galley, toilet door, crew rest module) showed that the airplane had likely struck the surface of the water in a straight line, with a high rate vertical acceleration.
