SERVICE BULLETIN

TITLE: STABILIZERS - INSPECTION/REPLACEMENT OF ELEVATOR BALANCE WEIGHT ASSEMBLIES

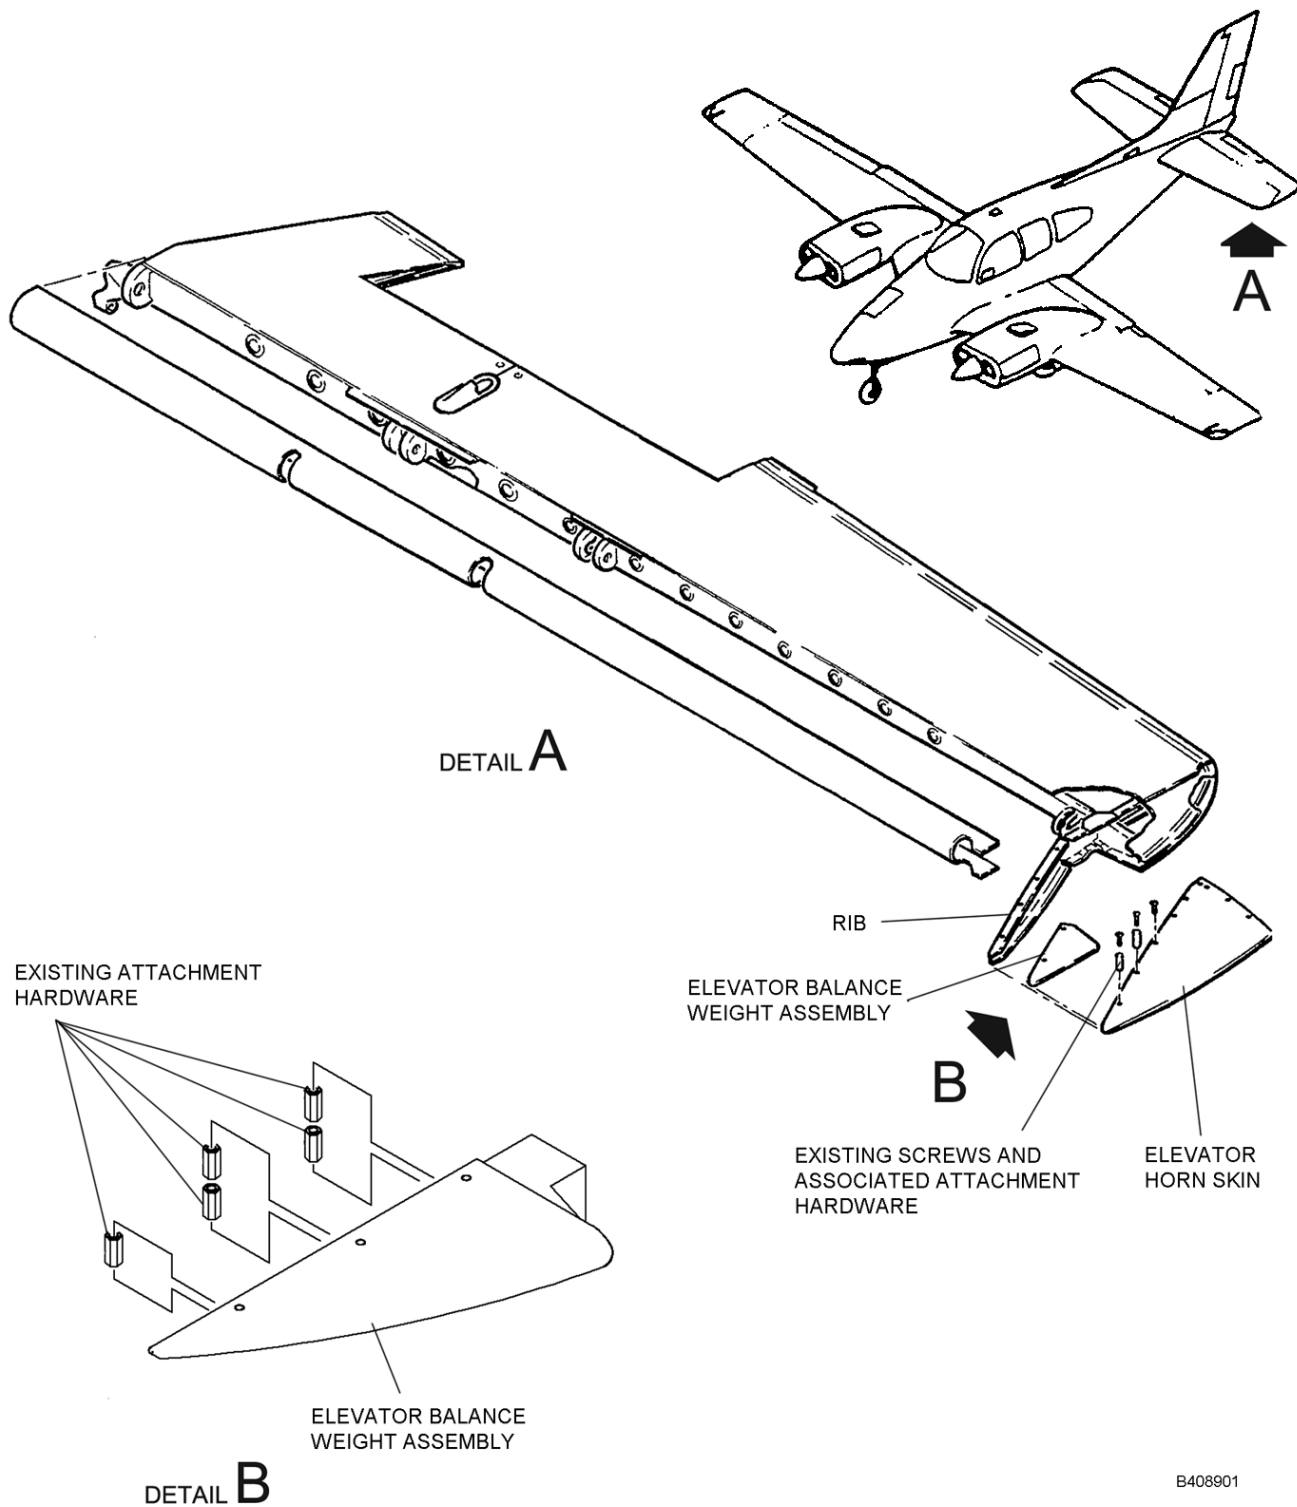
Inspection of Elevator Balance Weight Assembly
Figure 1

Elevator weights have been built to multiple type design revisions and may have five (5) inserts as shown in Figure 1 or four (4) inserts.

- (3) Visually inspect to determine if the existing elevator balance weight assembly is in position and protruding from the edge of the rib. In addition, verify that the elevator balance weight assembly attachment screws on upper and lower surfaces are secure and the installation holes show no sign of discoloration. Refer to Figure 1 and Figure 2.

- (b) If the existing elevator balance weight assembly has become dislodged, the attachment screws are not secure, or the installation holes show signs of discoloration, proceed to Step (4).

- (4) Remove the existing screws and associated attachment hardware from the elevator horn skin. Retain the removed screws and associated attachment hardware.

- (5) Remove the existing elevator balance weight assembly from its position under the elevator horn skin.
- (6) Weigh the removed elevator balance weight assembly to determine which replacement elevator balance weight assembly shall be installed. Part numbers apply to the weight of the removed elevator balance weight assembly as follows:
Elevator balance weight assembly, P/N 96-610022 = 3.4 +/- 0.10 LB
Elevator balance weight assembly, P/N 96-610022-5 = 3.55 +/- 0.10 LB
Elevator balance weight assembly, P/N 96-610022-7 = 3.9 +/- 0.10 LB
Elevator balance weight assembly, P/N 96-610022-9 = 4.10 +/- 0.05 LB

- (7) Use the screws and associated attachment hardware that were retained in Step (4) to install the applicable new elevator balance weight assembly. **Note:** New hardware may be used as necessary, as defined in Paragraph 2.C.2. The installed elevator balance weight assembly shall protrude from the rib as shown in Figure 2.
