No. 2518, Rev. I  
ATA Code 28-20

**SUBJECT:** FUEL - REPLACEMENT OF THE FUEL STRAINER SPRING AND HOUSING PLATE

## Service Bulletin No. 2518, Rev. I

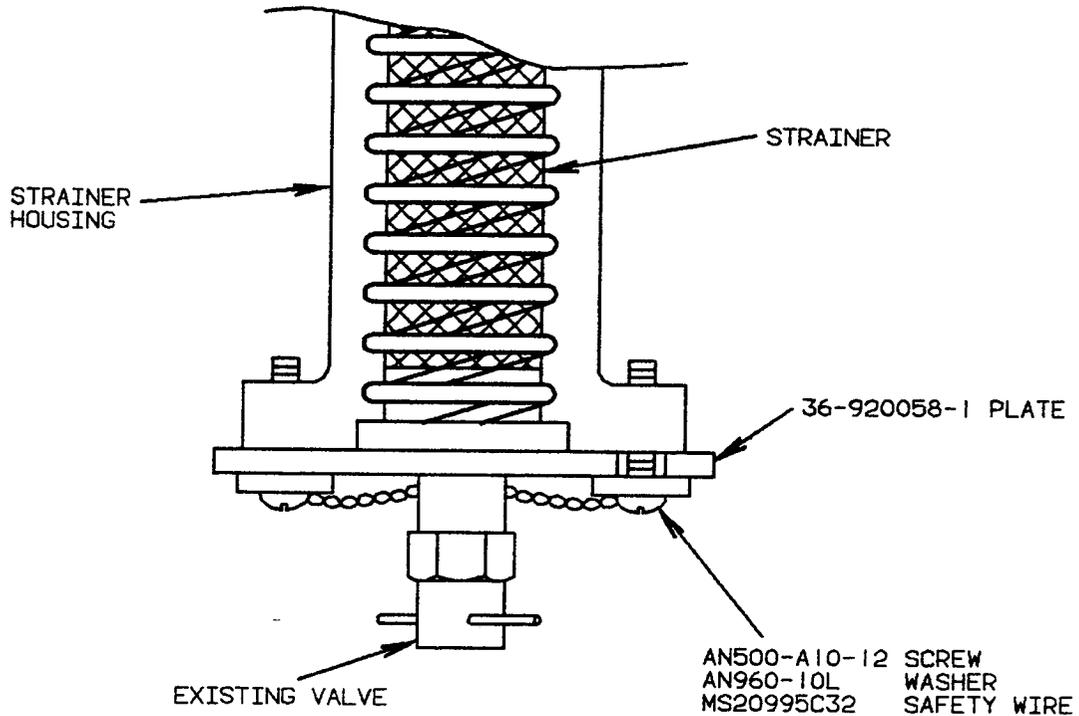
**Figure 1**

**REASON:** This Service Bulletin is being issued to replace the fuel strainer spring and housing plate with an improved housing plate. The new plate and spring come as one assembly and will prevent the strainer screen from being installed incorrectly. An incorrectly installed strainer screen may allow unfiltered fuel to enter the fuel system. Unfiltered fuel may contaminate the engine fuel system and cause engine power interruptions.

**Fuel Strainer Spring and Housing Plate**

1. Turn the fuel selector to the OFF position.
2. Gain access to the fuel strainer and remove the existing fuel strainer housing plate and fuel strainer spring from the bottom of the fuel strainer. See Figure 1. Remove and retain the valve from the housing plate and retain the attaching hardware. Discard the mounting plate, gasket and spring.
3. Use LOCTITE 592-31 (PST 592) to coat the drain assembly threads and install the valve into a new P/N 36-920058-1 housing plate. LOCTITE 592-31 (PST 592) is available through a BEECHCRAFT Authorized Outlet or may be procured from local sources.
4. Install a new P/N 35-921181 gasket on the new housing plate, place the strainer into

the spring (attached to the new plate) and attach the plate to the strainer housing using the two screws and washers which were removed in Step 3. Safety the two screws with P/N MS20995C32 safety wire (obtain locally).
