SPECIAL INVESTIGATION REPORT

DESIGN-INDUCED LANDING GEAR
RETRACTION ACCIDENTS IN
BEECHCRAFT BARON, BONANZA, AND
OTHER LIGHT AIRCRAFT

SIR
NTSB-SR-80-1

Adopted: June 24, 1980

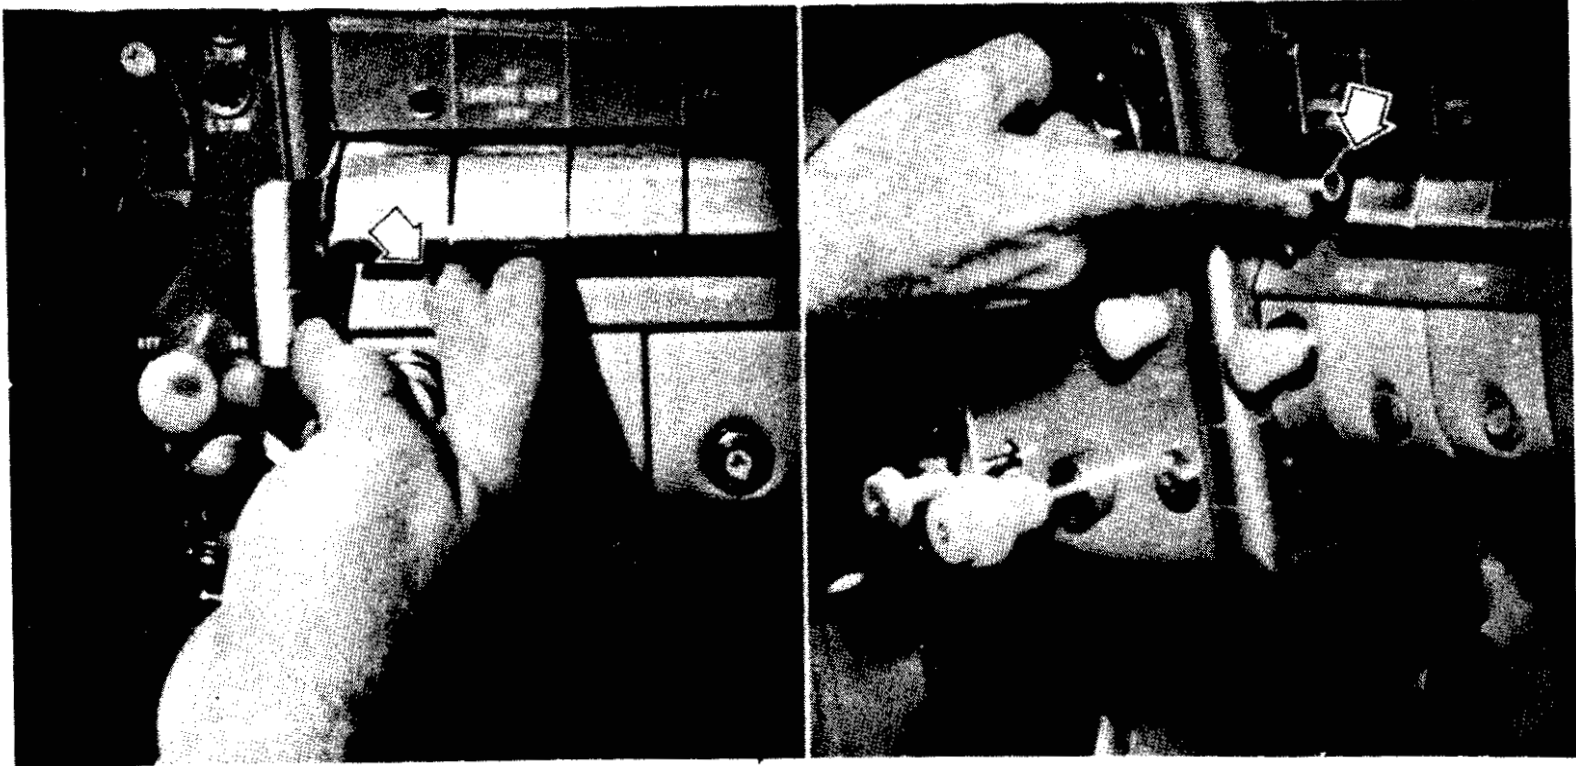
Figure 3.—Identically shaped tab-type control switches of early model Bonanzas (circa 1948). Note: Landing gear switch is in the neutral position in left photo and in the raised position at in right photo.

The lack of shape-coded control knobs has been documented on the early Bonanzas by the Safety Board special study cited previously. In describing these tab-type switches this report stated that ". . . the landing gear control and wing flap control are included in a row of similar switches or more precisely, nearly identical switches." (See figures 3 and 4) The accident rate of the Bonanza was more than twice the average rate for all aircraft with retractable landing gears. When Beech redesigned the Bonanza cockpit in 1963, they did incorporate full shape-coding on these controls, but they deleted the latch which had been incorporated on previous models.

Require that after a specified date, the landing gear control switch on the pre-1963 model Beechcraft Bonanzas be modified to incorporate a wheelshaped knob as outlined in 14 CFR 23.781. (Class II, Priority Action) (A-80-58)

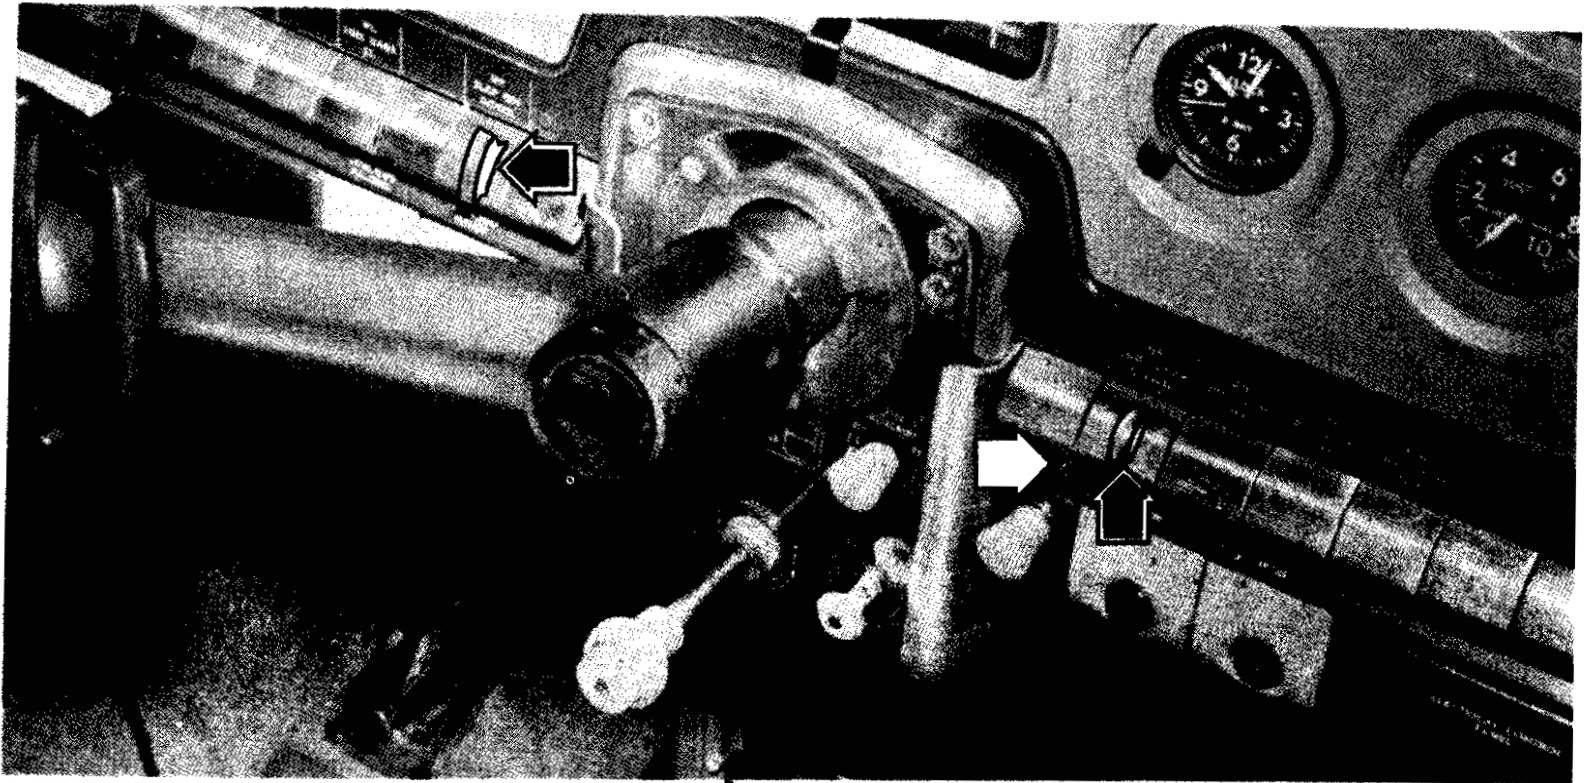
Figure 4.— Bonanza (circa 1955) with tab-type switches incorporating small protrusions on flap control and landing gear control on left and right, respectively. (See black arrows.) The safety latch for the landing gear switch is indicated by the white arrow.

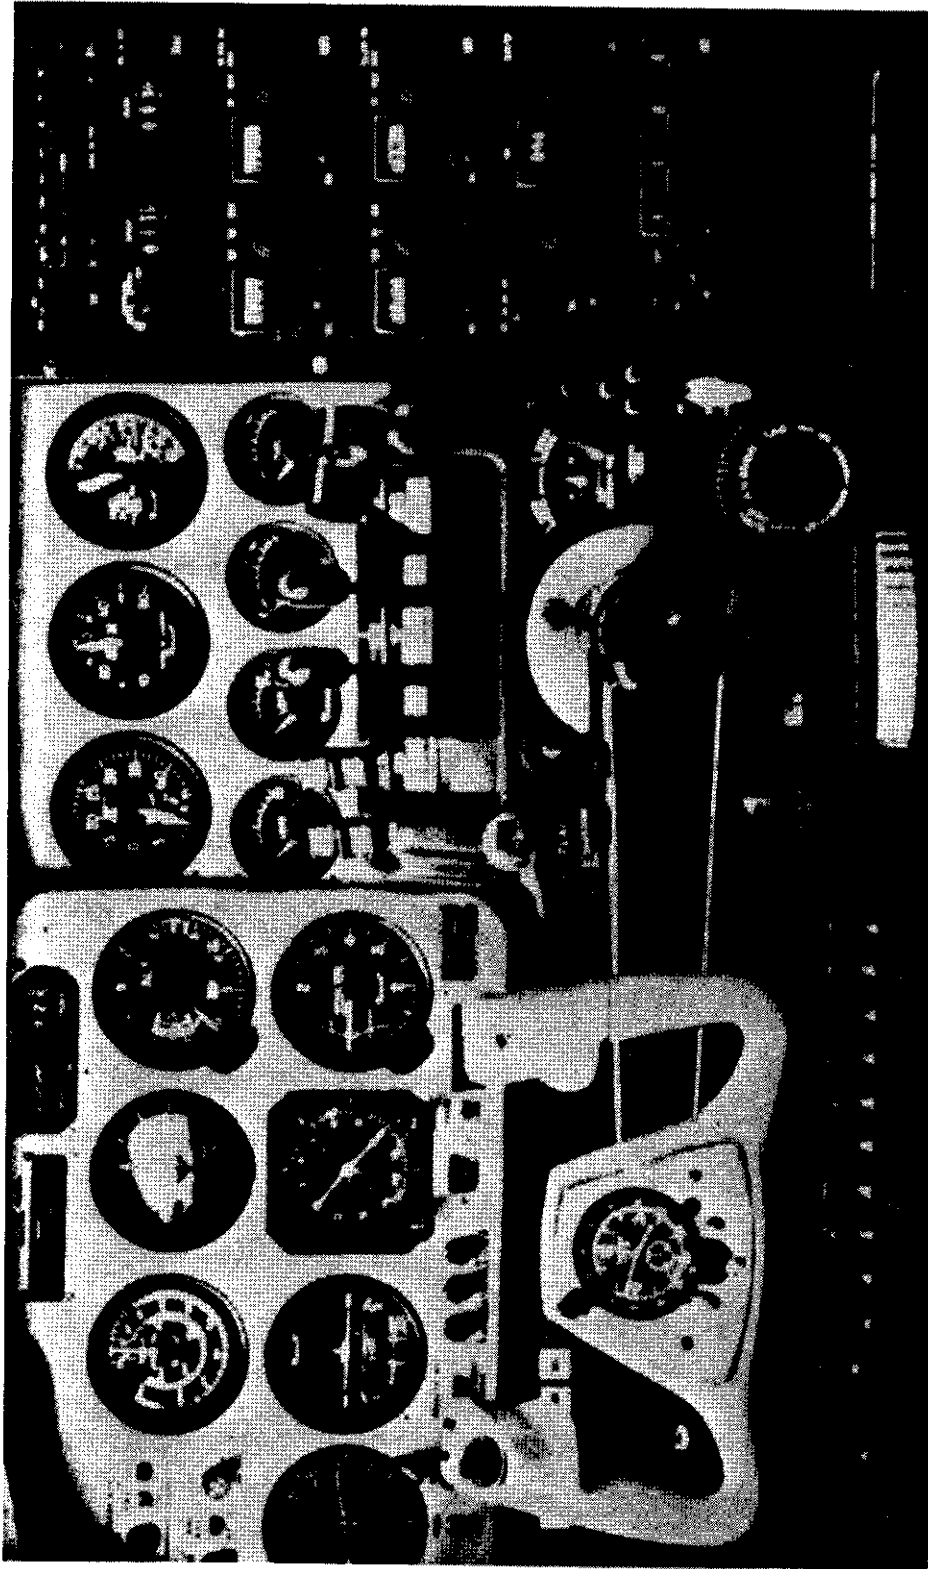
Figure 5.—Single control wheel mounted on a "throw-over" bar (late model Baron).

Obscuration of Controls.--The problem of inadvertent gear retraction on the Bonanza and Baron aircraft is compounded further by a design feature of the flight control system which is unique to these two aircraft. The system utilizes a large horizontal cross-bar on which the control wheel (or wheels) is mounted. The two versions of this control system are (1) the single control wheel with a "throw-over" mechanism which allows the wheel to be placed in front of either the left or the right front seat (see figure 5), and (2) the dual control model where wheels are available to both seats (see figure 6).

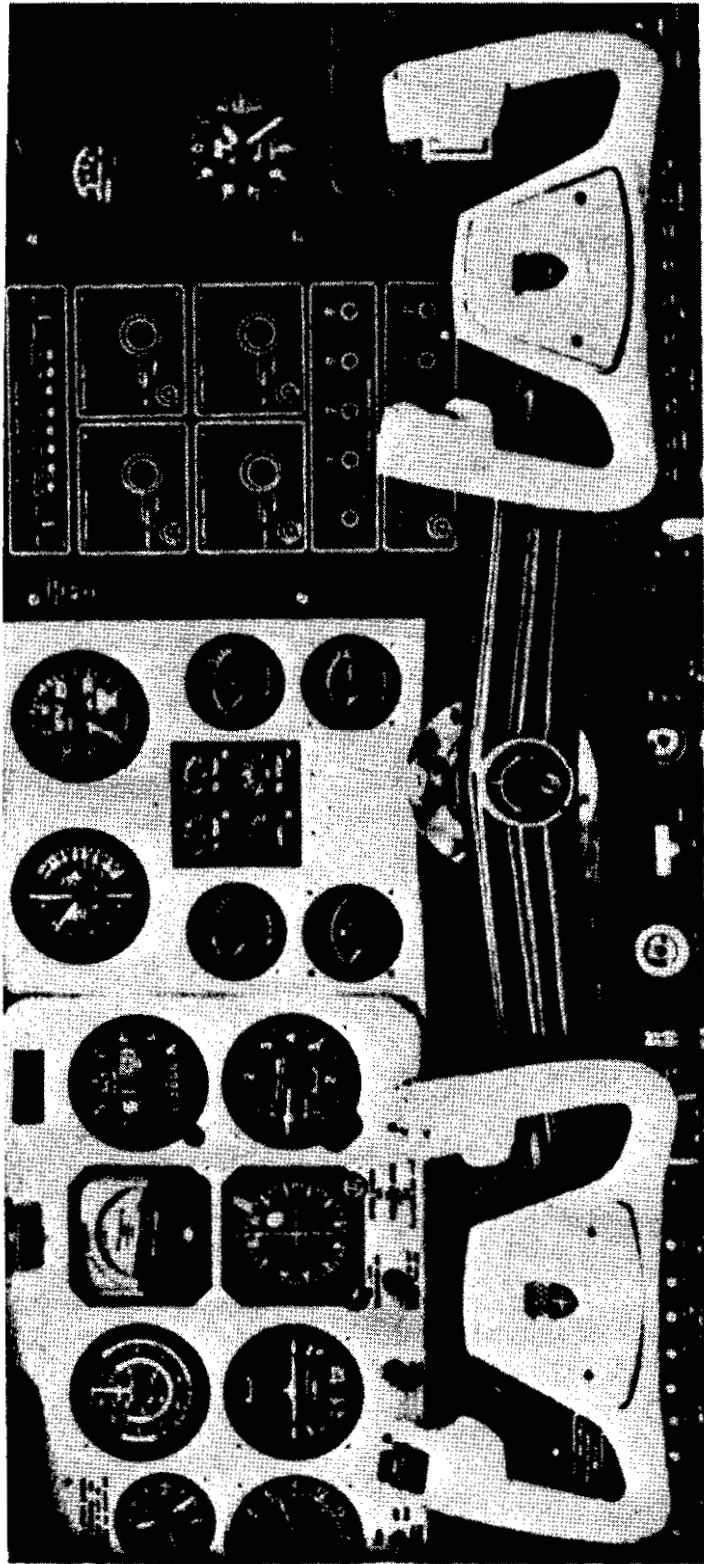
Figure 6.—Dual control wheels on bar (late model Bonanza).

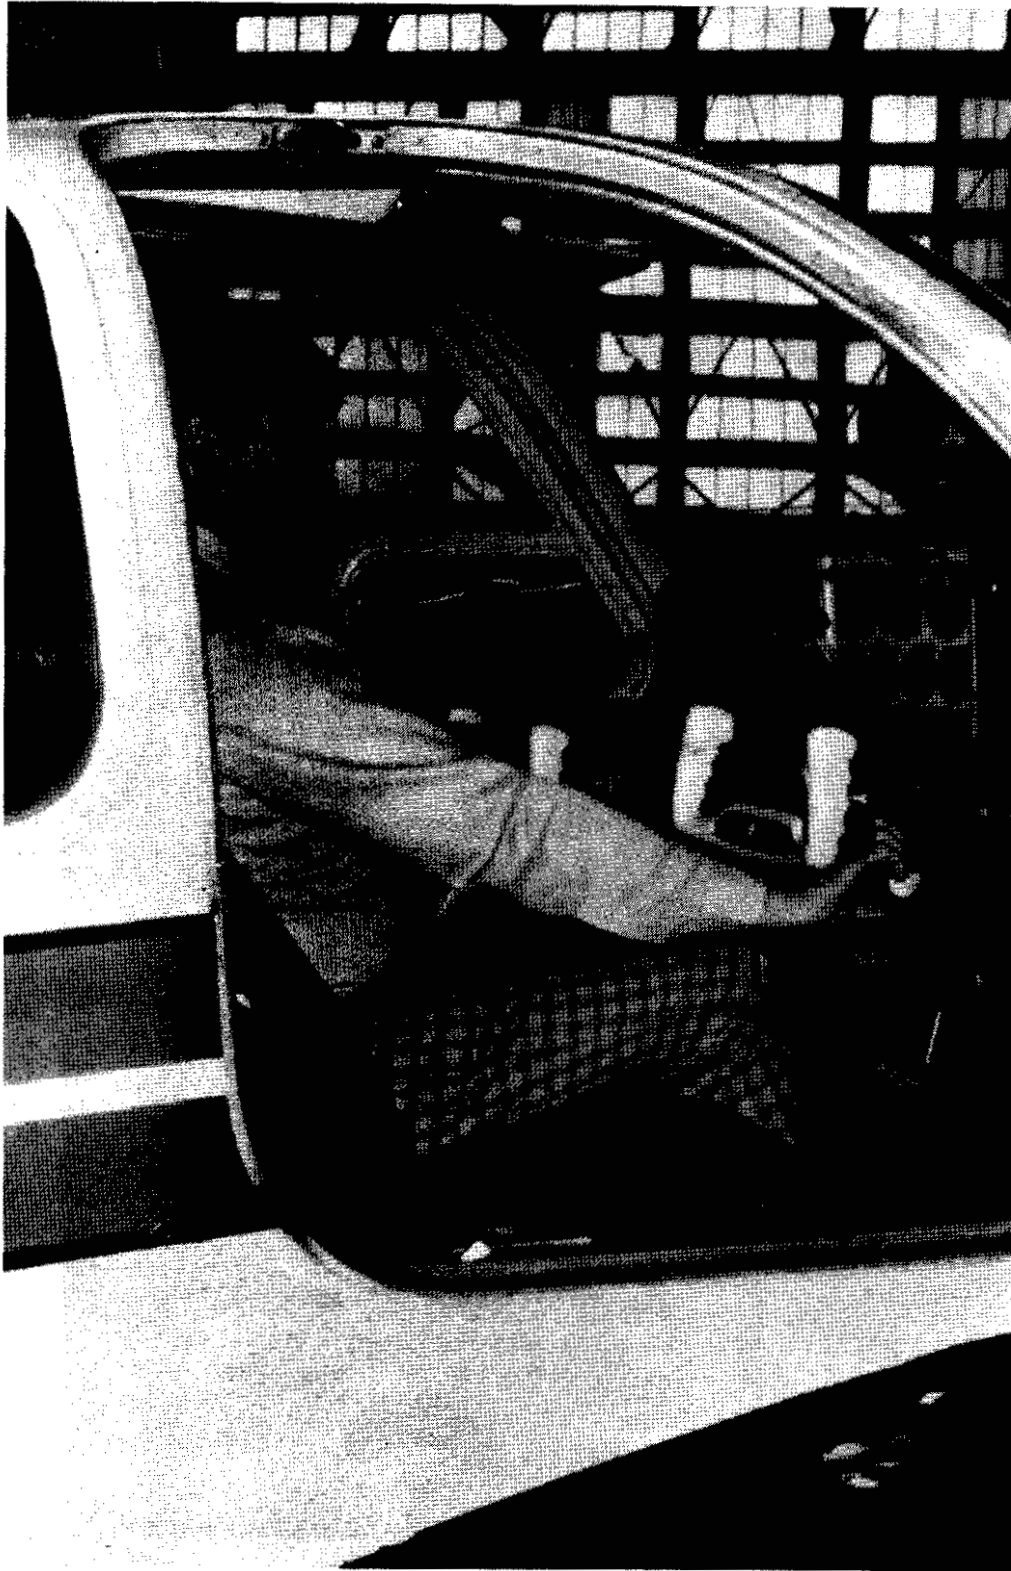
Figure 7.—Pilot reaching underneath the control wheel bar to locate obscured landing gear control switch.

There are two problems associated with this control system: (1) the horizontal bar is large enough to block the pilot's view of the gear and flap control switches forcing the pilot to rely on his sense of feel to identify the desired control, and (2) the pilot must reach around the bar to activate these controls. (See figures 7 and 8.) Both of these problems are more of a hindrance to pilots of small stature and when the wheel is relatively far forward. The control switches are relatively small in comparison to those on many other aircraft. This also tends to decrease the pilot's ability to differentiate those controls by feel.

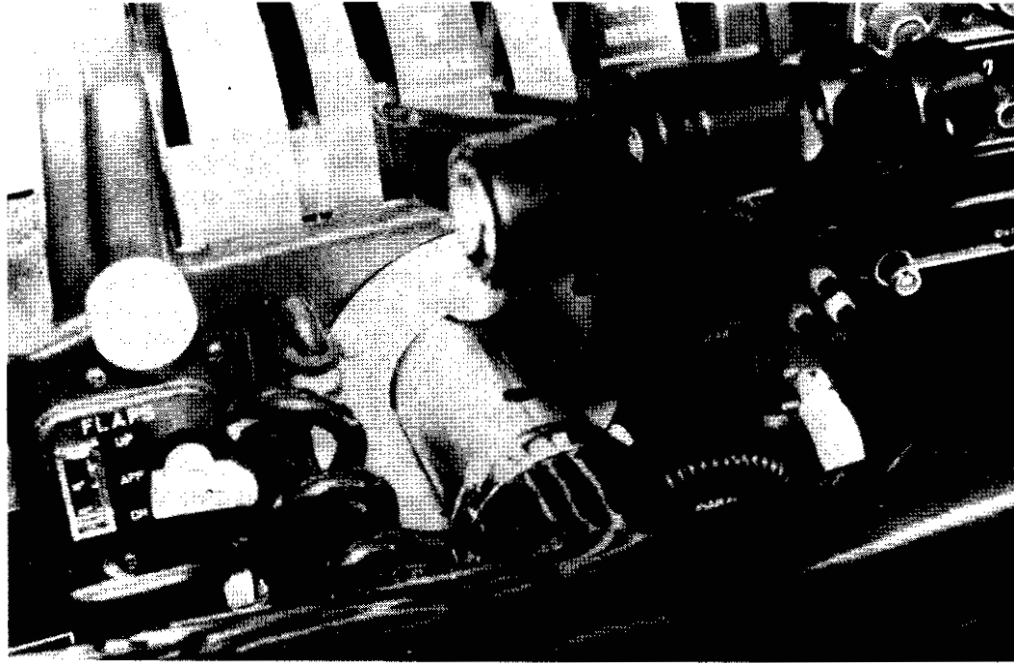
Figure 8a.—Pilot's view of landing gear and flap switches partially obscured by the control wheel bar.

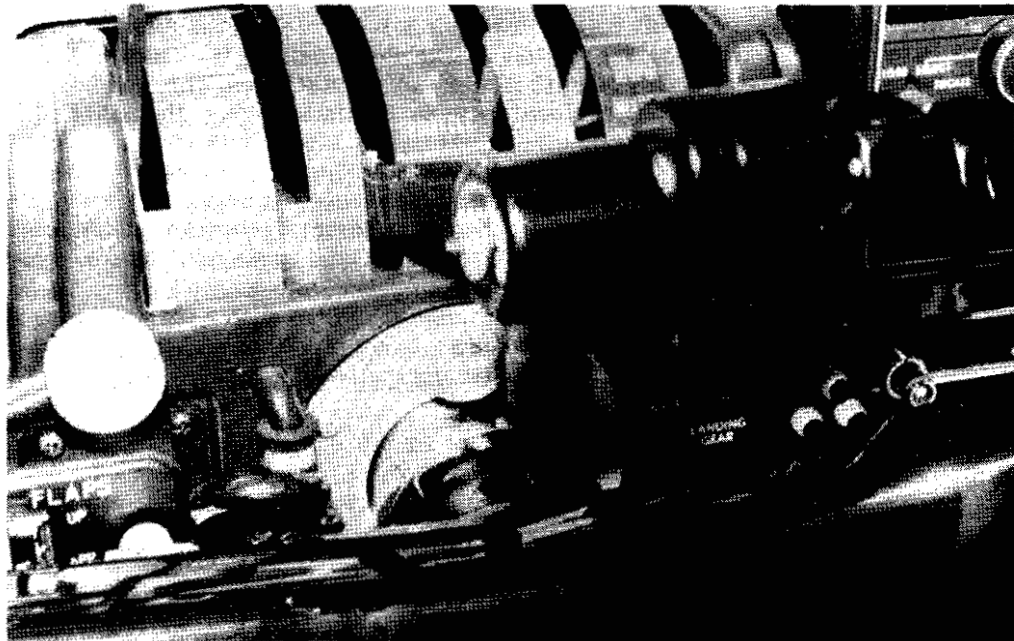
Figure 8b.--Pilot's view of landing gear and flap switches obscured by control wheel bar.

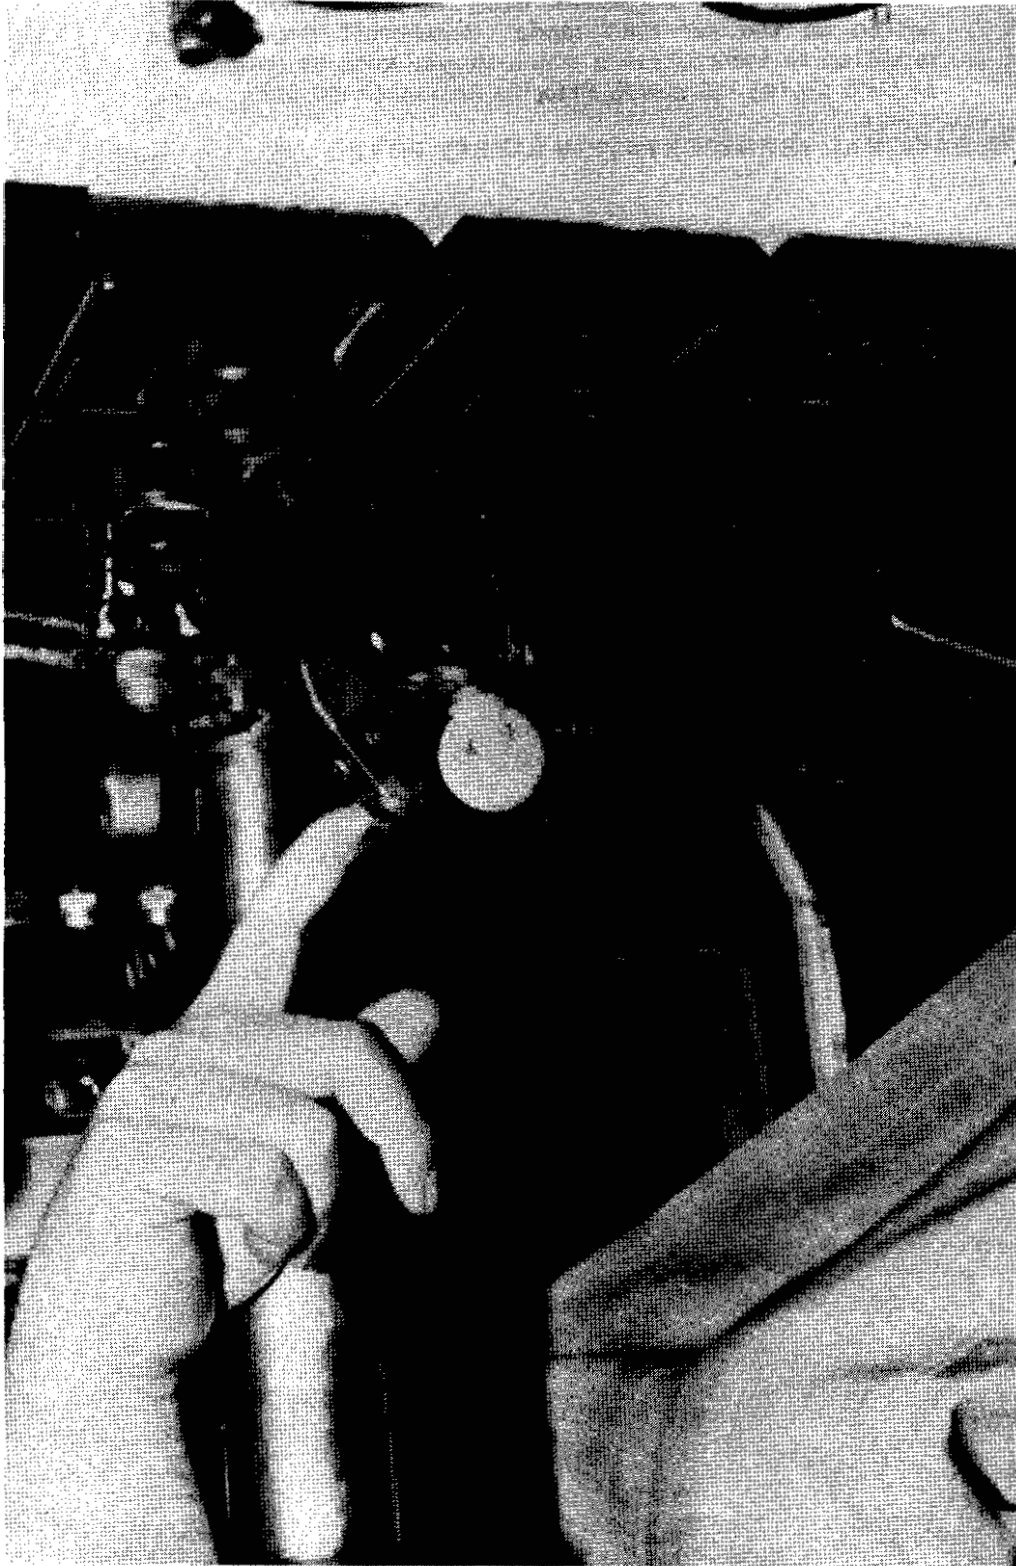
Figure 9.--FAA-designed guard for landing gear control switch (being lifted).

The increased potential for inadvertent landing gear retraction accidents on the Baron was recognized by FAA in 1973, when the agency retrofitted its own Barons with a special guard over the landing gear control. This guard must be raised before the gear control can be put in the "UP" position. (See figure 9.) This FAA-developed device is a simple spring-loaded guard that is attached to the instrument panel. ^{10/} The cost of the parts (a modified toggle switch guard and attaching screws) was minimal. The largest expense was the labor involved. FAA mechanics suggested that this was due to the prototype nature of the modification, which required removal of the control wheel bar and instrument panel cover.

Require that after a specified date, previously manufactured Beechcraft Baron and Bonanza aircraft which do **not conform to the** landing gear and flap control arrangements outlined in 14 CFR 23.777, **be** equipped with an adequate guard **or** latch mechanism to prevent inadvertent actuation of the landing gear controls. (Class II, Priority Action) (A-80-57)
