No. 2360  
ATA Code 53-10  
Recurring Inspection

**SUBJECT:** FUSELAGE - WING FORWARD SPAR CARRY-THRU STRUCTURE INSPECTION AND/OR REINFORCEMENT

**Service Bulletin No. 2360**

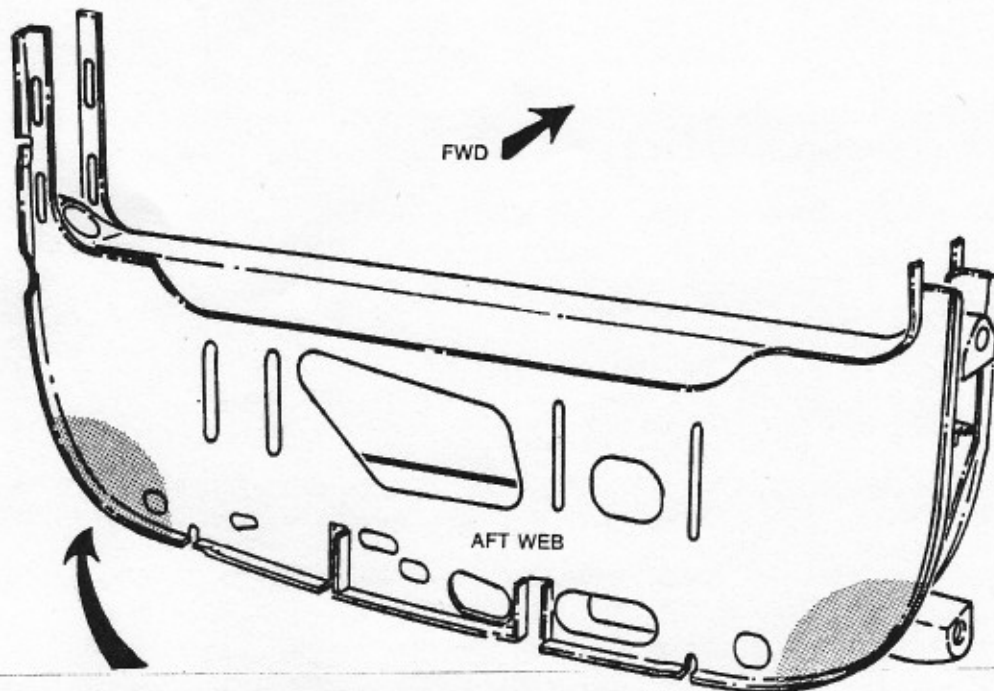
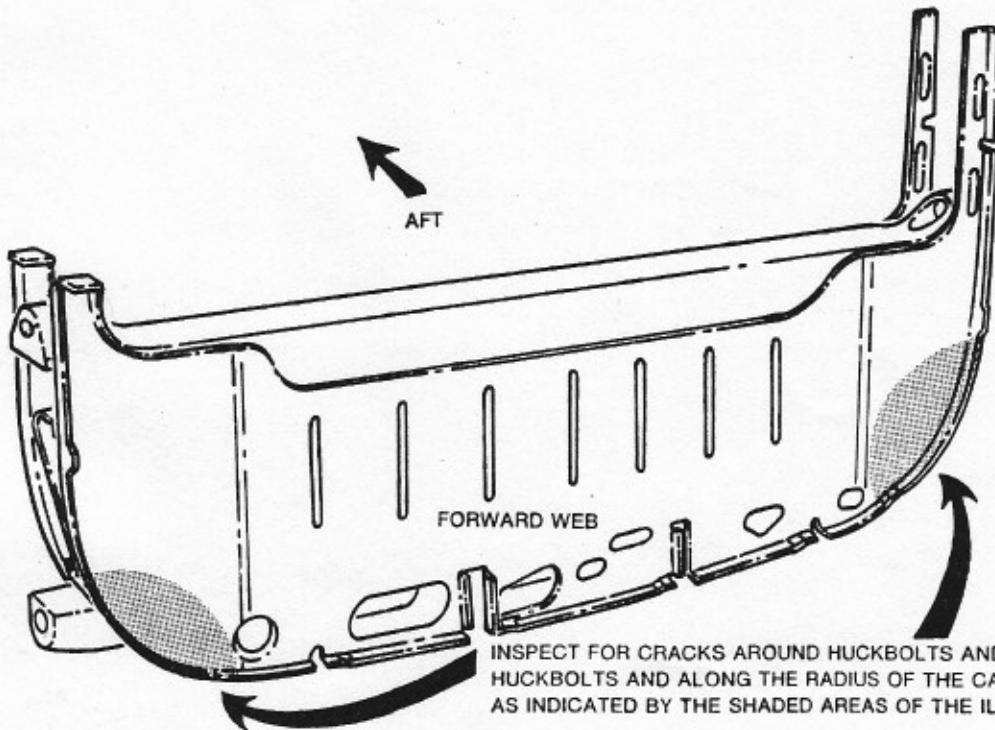
Inspection for Cracks in the Wing Forward Spar Carry-Thru  
Figure 1

**REASON:** This Service Bulletin is being issued to provide inspection and repair information relating to forward wing spar carry-thru structure forward and aft frames. Reports of frame (web) cracking have been received on in-service airplanes. If these cracks are detected at any time, the repairs described in this Service Bulletin should be applied.

INSPECT FOR CRACKS AROUND HUCKBOLTS AND BETWEEN HUCKBOLTS AND ALONG THE RADIUS OF THE CARRY-THRU WEB AS INDICATED BY THE SHADED AREAS OF THE ILLUSTRATION

The extent of repair is limited to cracking in the radius of the web flange and cracks in the web flat areas at the fasteners of the lower front spar cap.

1) A crack up to 2.25 inches in length must be stop drilled #30 at crack ends and inspected for progression at each annual inspection or every 200 hours, whichever occurs first. One stop drilled crack per left side and one stop drilled crack per right side of the wing forward spar carry-thru structure bend radius are permissible, if neither one exceeds 2.25 inches.

2) A crack between 2.25 inches and 4.0 inches in length shall be stop drilled #30 at crack ends. The area is to be repaired per the applicable P/N 36-4004 Kit within the next 100 flight hours.

3) A crack exceeding 4.0 inches in length shall be repaired prior to further flight per the applicable P/N 36-4004 Kit.

1) A crack less than 1.0 inch in length or one crack between two fasteners does not require immediate repair, but shall be inspected for progression at each annual inspection or every 200 hours, whichever occurs first. A crack emanating from one fastener in two directions is considered to be one crack. **Do not stop drill, due to the possibility of damaging structure behind web face.** One crack per left side and one crack per right side of the wing forward spar carry-thru structure web face are allowed, if neither one exceeds 1.0 inch.

2) A crack more than 1.0 inch in length shall be repaired per the applicable P/N 36-4004 kit, within the next 25 flight hours.

A crack which passes through two fasteners but is less than 0.5 inch beyond either fastener shall be repaired per the applicable P/N 36-4004 kit within the next 25 flight hours.

3) A crack passing through two fasteners and extending beyond for more than 0.5 inch on either end shall be repaired prior to further flight, per the applicable P/N 36-4004 kit.

c. A combination of the cracks described in Steps "a" and "b" is acceptable. If cracks are found in both the forward and aft web face and/or the bend radius on the same side of the airplane, and any of the cracks are more than 1.0 inch long, a repair shall be made prior to further flight.

6. Repair all cracks per the appropriate P/N 36-4004 Kit if the limitations in Steps "5a", "5b", or "5c" are exceeded.
