SERVICE BULLETIN

Beech**ATA Code 27-20**

TITLE: FLIGHT CONTROLS - RUDDERVATOR DIFFERENTIAL TAIL CONTROL ROD ASSEMBLY INSPECTION/MODIFICATION

SB 2668, Rev. 2

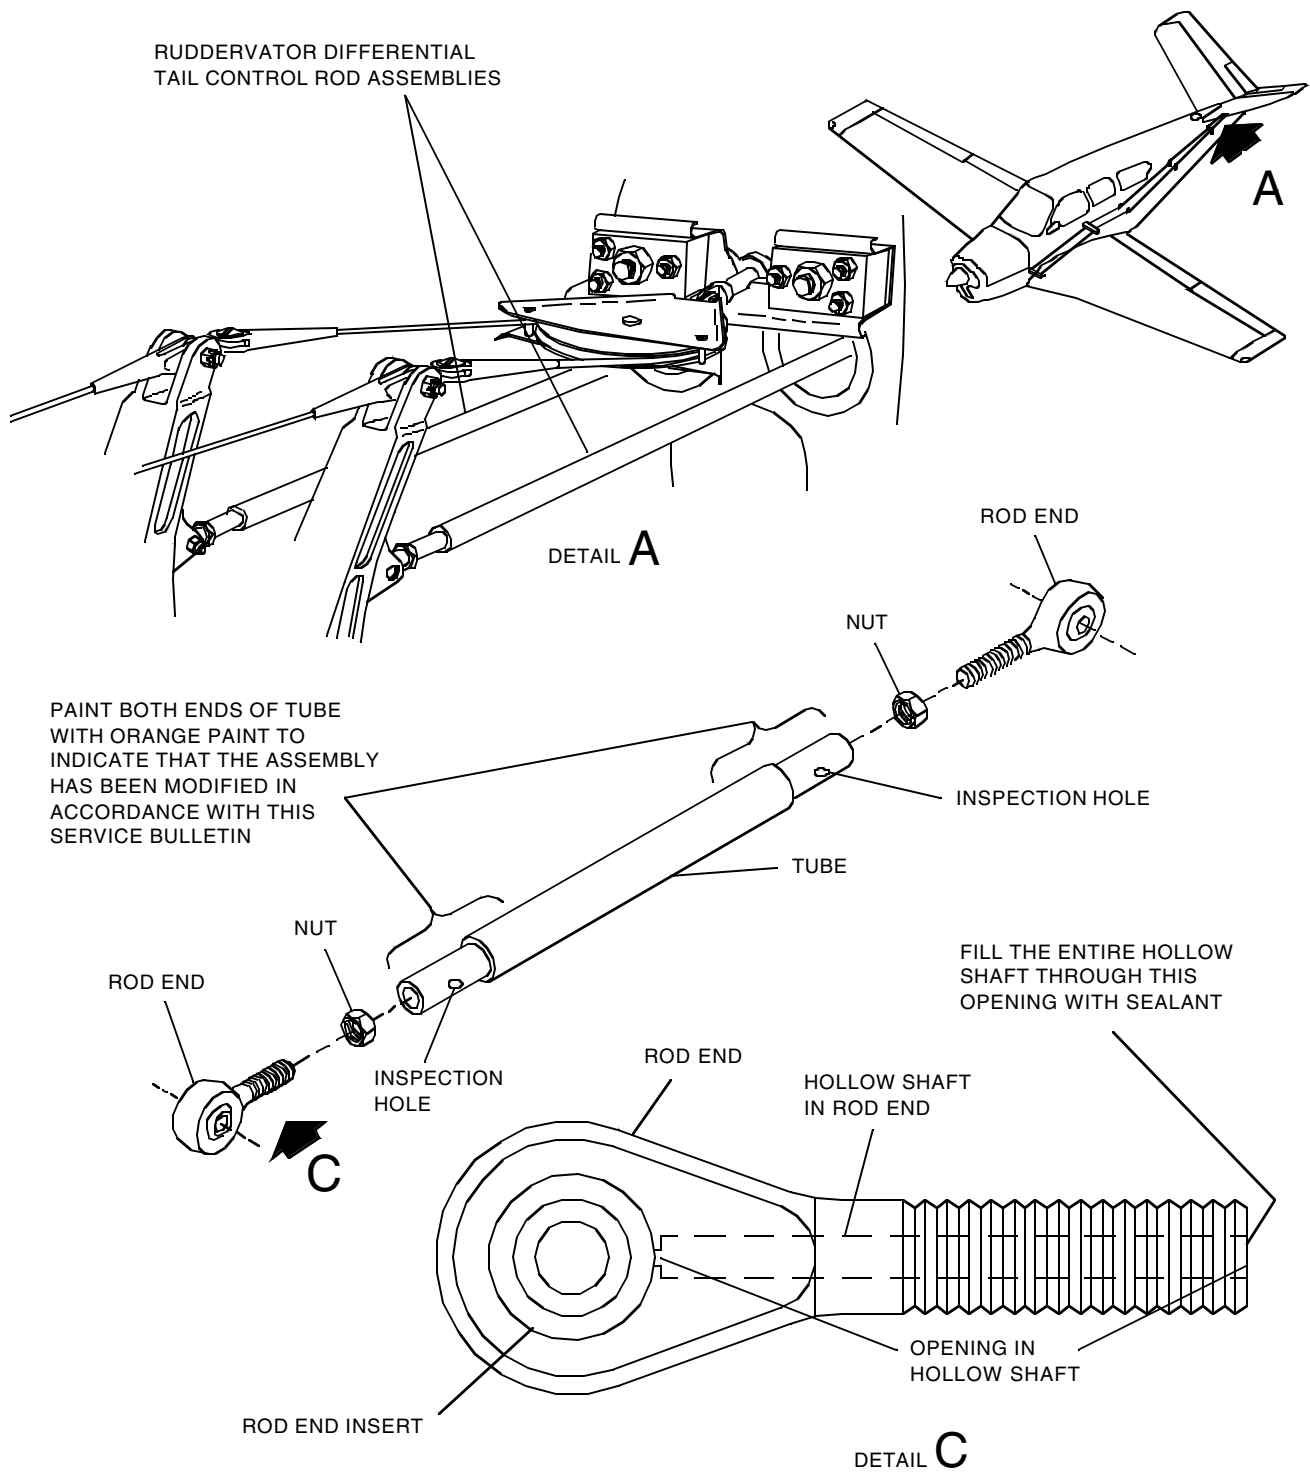
Ruddervator Differential Tail Control Rod Assembly
Figure 1

Each differential tail control rod assembly has two rod ends which are installed in the ends of the assembly. These rod ends (with the exception of P/N AHM4-1006) have a hollow shaft which is open at both ends and extends through the length of the rod end. It appears that through the process of the rod assembly "breathing", moisture laden air enters the rod assembly through the hollow shaft in the rod ends and condenses in the rod assembly tube. The accumulation of moisture in the assembly tube, in the presence of freezing temperatures, may cause the tube to split and possibly lead to the ruddervator not operating properly.

- (1) Remove all power from the airplane and disconnect the battery. Display warning notices prohibiting reconnection of airplane electrical power.
- (2) Accomplish the following using Figure 1 for reference.
- (3) Remove the tail cone and any access covers/panels required to gain access to the two ruddervator differential tail control rod assemblies.
- (4) Inspect all four (4) rod ends for P/N identification and refer to the following note.

- (14) If no cracks or corrosion are found in the rod ends perform the following steps using Detail C for reference:
 - (a) Clean the hollow shaft in each rod end with solvent and allow to dry.

- (b) Fill the hollow shaft with P/N MIL-S-8802, Class B sealant and allow to cure.
 - (c) After the sealant has cured, lubricate the ball and groove in the rod end insert with P/N MIL-G-23827 grease.

- (d) Reidentify the modified rod end as P/N 35-524106-9 using an indelible marker.
- (15) Apply P/N MIL-C-22750 orange epoxy, enamel, or polyurethane paint to the first two inches of each tube end and allow to dry. If corrosion preventative compound is present when the paint is to be applied, remove it with P/N MIL-C-38736 solvent before painting.
