National Transportation Safety Board Aviation Accident Preliminary Report

Location:	Monroe, WI	Accident Number:	CEN19LA290
Date & Time:	August 27, 2019, 12:00 Local	Registration:	N6245V
Aircraft:	Beech 35	Injuries:	1 Serious, 1 Minor
Flight Conducted Under:	Part 91: General aviation - Personal

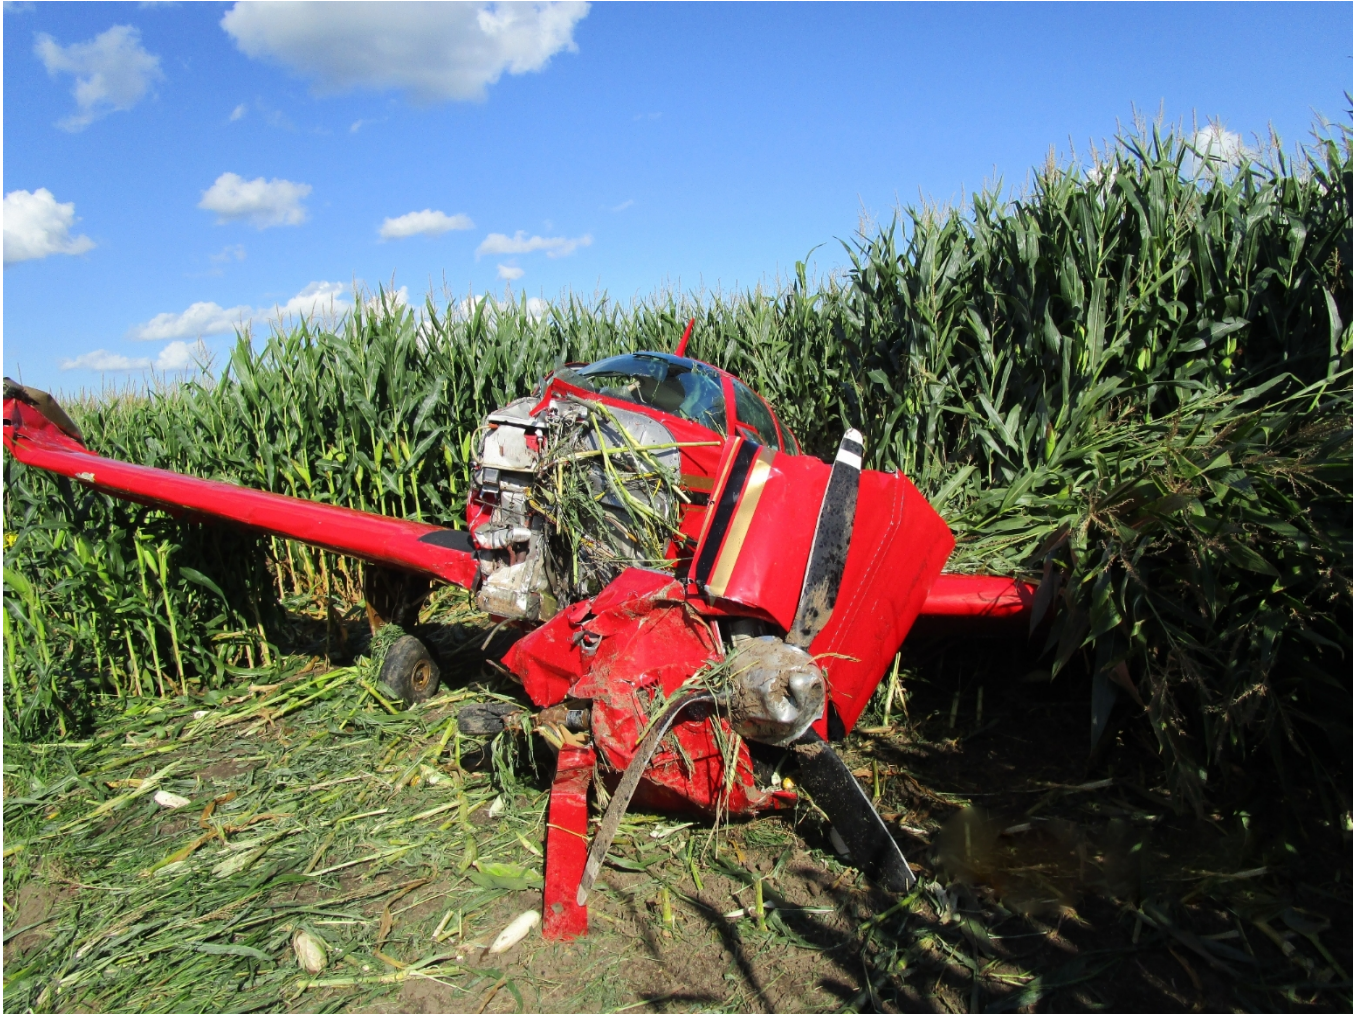
After the accident, the pilot stated that while in cruise flight the oil pressure decreased to 5 psi and the engine failed suddenly. The pilot diverted toward EFT and was unable to make the airport so he made a forced landing to a mature corn field (figure 1).

Figure 1 – Airplane in a corn field
