I recently discovered I had a voltage regulator that was not regulating. This sent me on a quest to find a new one or someone who could repair it. The former seems to be answered by Lamar, who appear to make the only suitable replacement, and I never found the latter. Somebody gave me a contact at Electromech but they never responded, so I was on my own.

It turns out a hangar neighbor went through the same thing on his F Bonanza some time ago and went the Lamar replacement route. He happened to still have his old broken regulator, which was the same part number as mine, and offered it to me to dissect. I decided to see if I could fix his and mine, purely for the intellectual challenge and not to install back in the airplane because, of course, I am not a certified avionics shop.

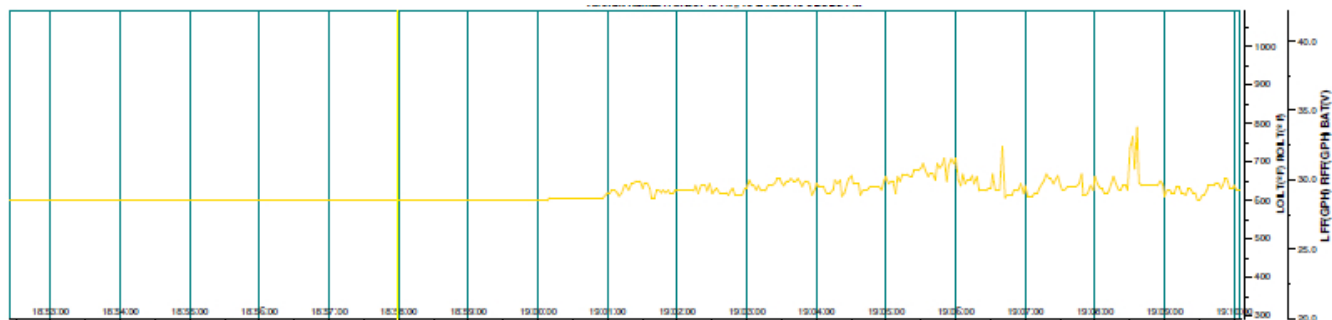
On the first regulator, the field voltage on the bench followed the bus voltage up to 32V and tripped, i.e., there was no regulation of the alternator and in flight the voltage eventually increased until it hit the OV trip point. My regulator did the exact same thing, as shown in the attached JPI download. I will spare the debug details except to note that, when testing on the bench, the field output will not behave properly with an open circuit, i.e., you have to load the field so the 2N3055 emitter can dissipate instead of floating. I picked the fattest resistor I had handy, which I think was a couple watt, 1k resistor. It turns out in both bad regulators the field drive transistor, the familiar 2N3055---coincidentally the same one that drives our panel lights---was shot. A replacement brought both my and his regulator back into working order. The fix was that simple.

On my regulator the OV trip function was also not tripping consistently, something I noticed in the JPI download and verified on the bench. On the bench, sometimes the relay would click when the input voltage was above 32V, sometimes not, and by accident I discovered the OV circuit would work when the back of the board was randomly touched. Not regulating and also not tripping is A Bad Thing. Looking with an eye loupe I found what appeared to be a cold solder joint (the board was hand soldered) as well as a PCB trace that had been scraped off to the point of, I suspect, causing an intermittent circuit. The scrape occurred at the board edge, on a pad closest to where the board slid into a slot in the aluminum housing. From the width and characteristics of the scrape, it looks like the assembler initially put too much solder on the pad and the board edge could not fit into the housing slot, so s/he scraped off the pad until it did fit. Unfortunately, s/he also scraped off the underlying PCB trace. I do not know if either the cold solder joint or the scraped trace was the cause of my OV circuit not working (they were both on the SCR gate leg), but once retouched with an iron it all works fine.

Here is what a bad VR looks like-- this is my JPI download showing bus voltage during one of the first flights after installing a JPI in my new to me airplane, by which time I suspected I had a bad VR because the alternators would every once in a while go off line. I had isolated it to VR#2 (my habit is to switch before every startup) and on this flight I switched from VR#1 to VR#2 around 19Z to get the data. It regulated OK for a minute or so before losing grip (I think this might have been coincident with turning on the landing lights). At ~19:08:30 it actually went to 33.8V but did not trip off. Engine RPM was constant the whole time.

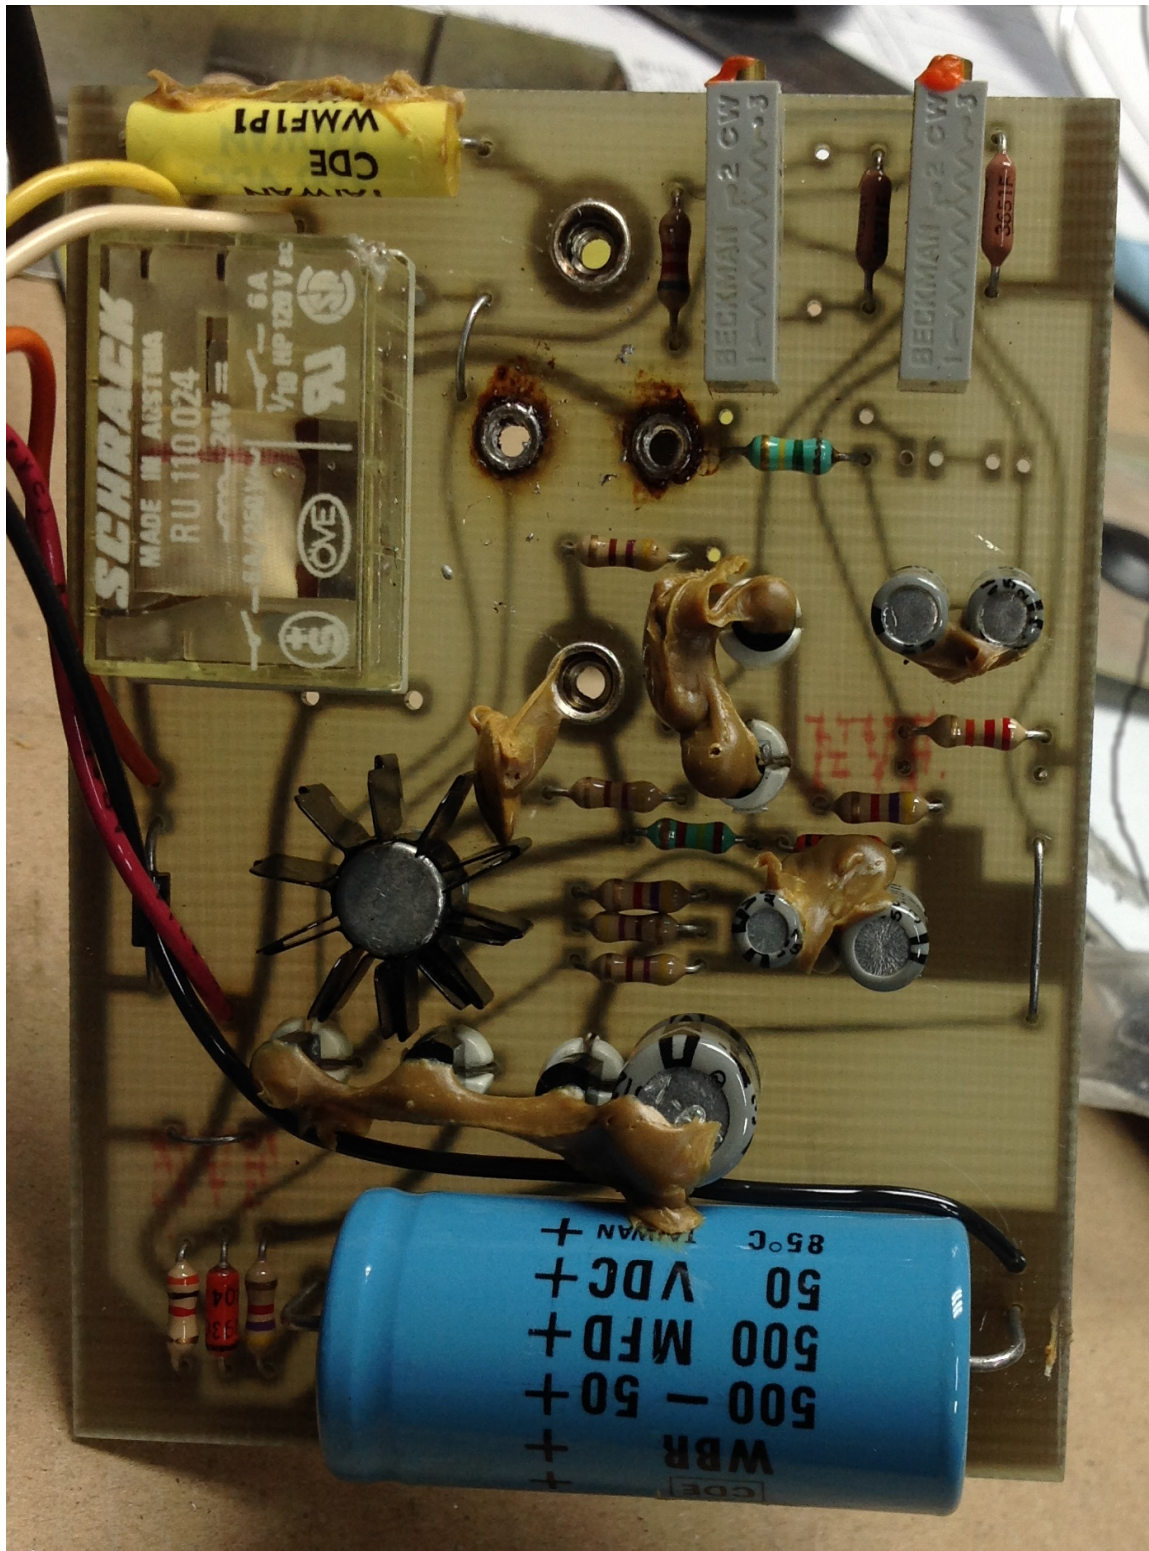
Picture of the board. The empty holes are where the 2N3055 gets soldered & screwed in. It is mounted externally.

If anyone is similarly replacing their 2N3055 transistors for their VR or, for that matter, their panel lights, replace them with 3055H. The H suffix is a slightly more robust version compared to what you used to be able to find in Radio Shack. The H also happens to be the official number called out by the parts book for the panel lights.

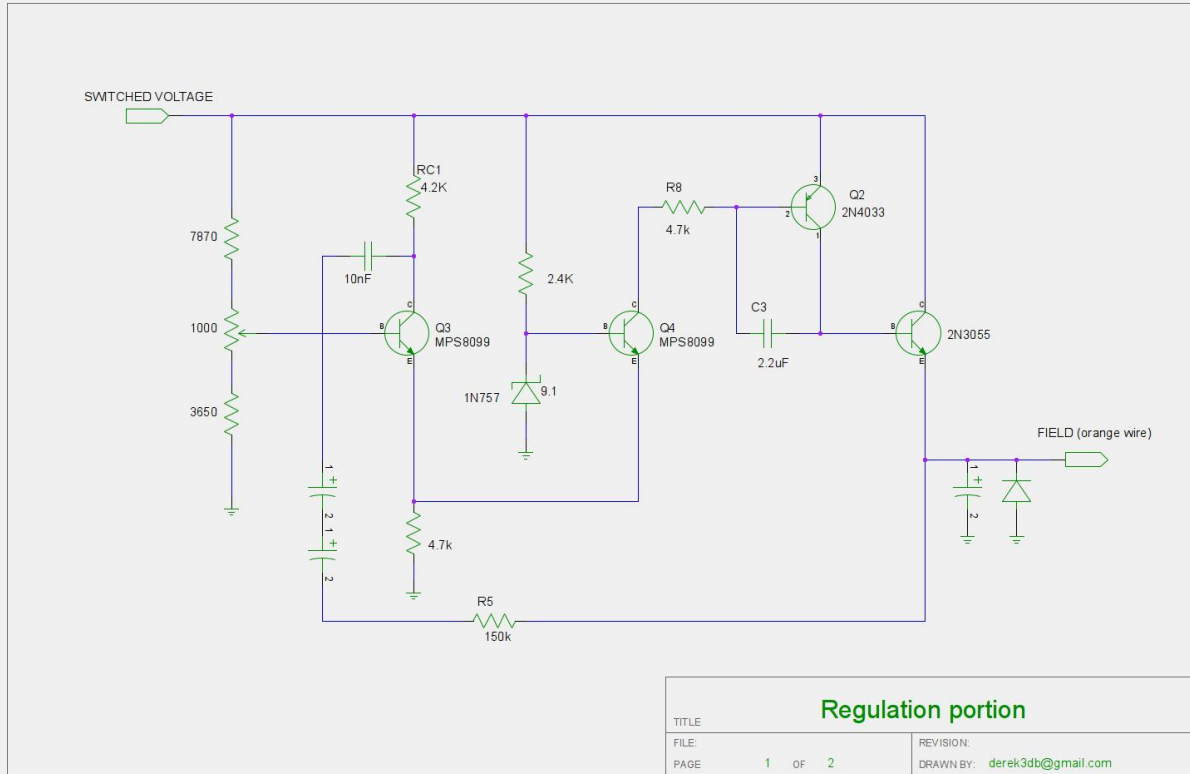
The regulator portion operates in a similar manner in that it has an NPN transistor with a base voltage that is about one third of the bus, and an NPN with base voltage set by a zener, which keeps the base at a constant $\sim 9V$. In this case, the two lines intersect around 28.5V, also adjusted by the trim pot. When the voltage is below the adjusted regulation point, the zener-fed transistor is on because its base voltage is higher, which turns on a slightly bigger transistor to drive the even bigger 2N3055 that supplies the field. Above the regulation point everything turns off and there is no field and no alternator output.

Regulator portion of the schematic.

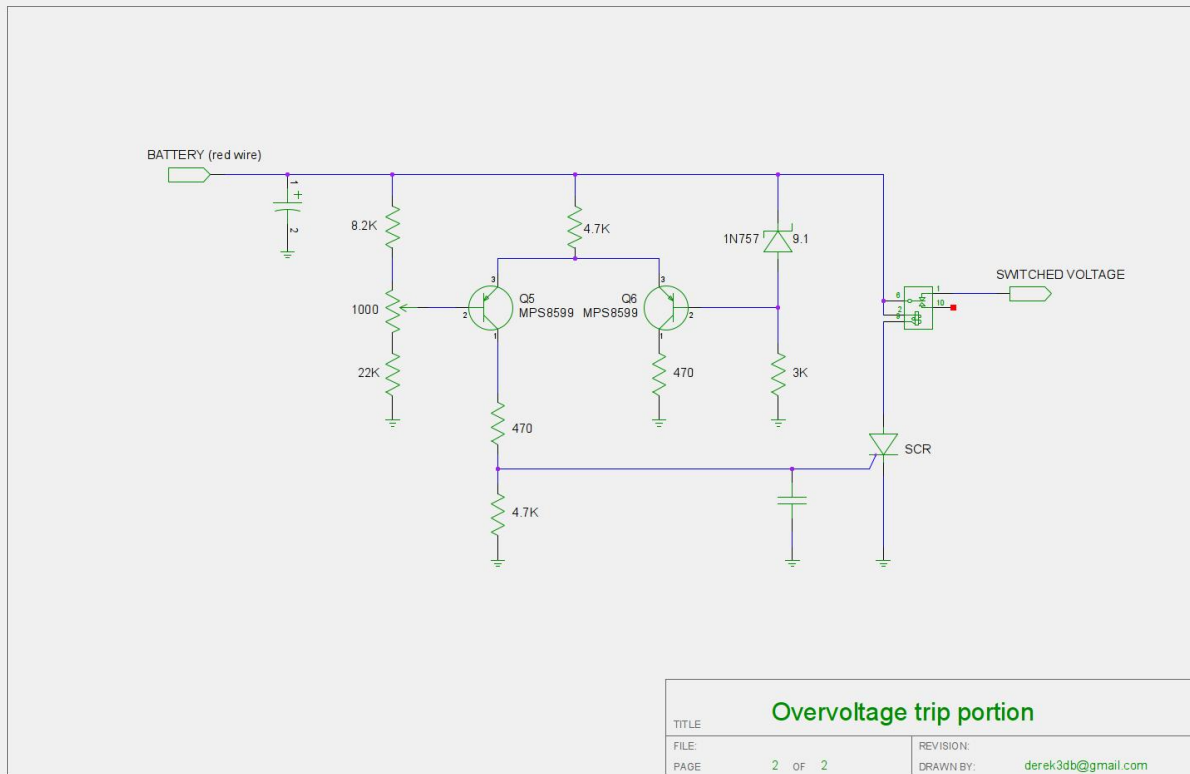
The overvoltage circuit passes the bus voltage ("battery" pin) through a relay, whose output is labeled "switched voltage", and on to the regulation circuit. The OV circuit has two PNP transistors; one has a base voltage picked off of a divider that follows at about 70% of the bus voltage, the other has a base voltage that is kept around 10V less than the bus by the zener diode. These two voltage lines intersect (i.e., when $0.7x = x - 10$) at $x = 32V$, as fine tuned by the trim pot. The two transistors are like a see-saw, either one is conducting ("on") or the other, teetering around the trip point. Until the trip point is reached, the zener-fed transistor is on because its base voltage is lower, and the divider-fed one is off. The reverse is true after the trip point; turning on the divider-fed transistor after the trip point applies a gate voltage to the SCR (or thyristor), which then conducts and energizes the relay coil. This opens the relay and interrupts the voltage being fed to the regulator circuit, killing the field and therefore the alternator. The SCR will continue to conduct and keep the relay open even if the transistor turns off and stops supplying the gate voltage (which it will do once the alternator is off and bus voltage goes to the battery voltage), and is why the batteries have to be turned off to reset the VR after an OV trip.

Overvoltage portion. The input (“Battery”) is synonymous with bus voltage.

The -5 version has another capacitor in parallel to the one already shown on the SCR gate. The one here might be drawn wrong, instead I think it's electrolytic, value unknown; I wasn't paying close attention to caps.

The schematic does not show it, but there is a white wire going from the unused relay output (arbitrarily labeled pin 10 here) to pin D on the VR connector. The VR labels it “overvoltage indicator” but it is not used, at least on the Baron.

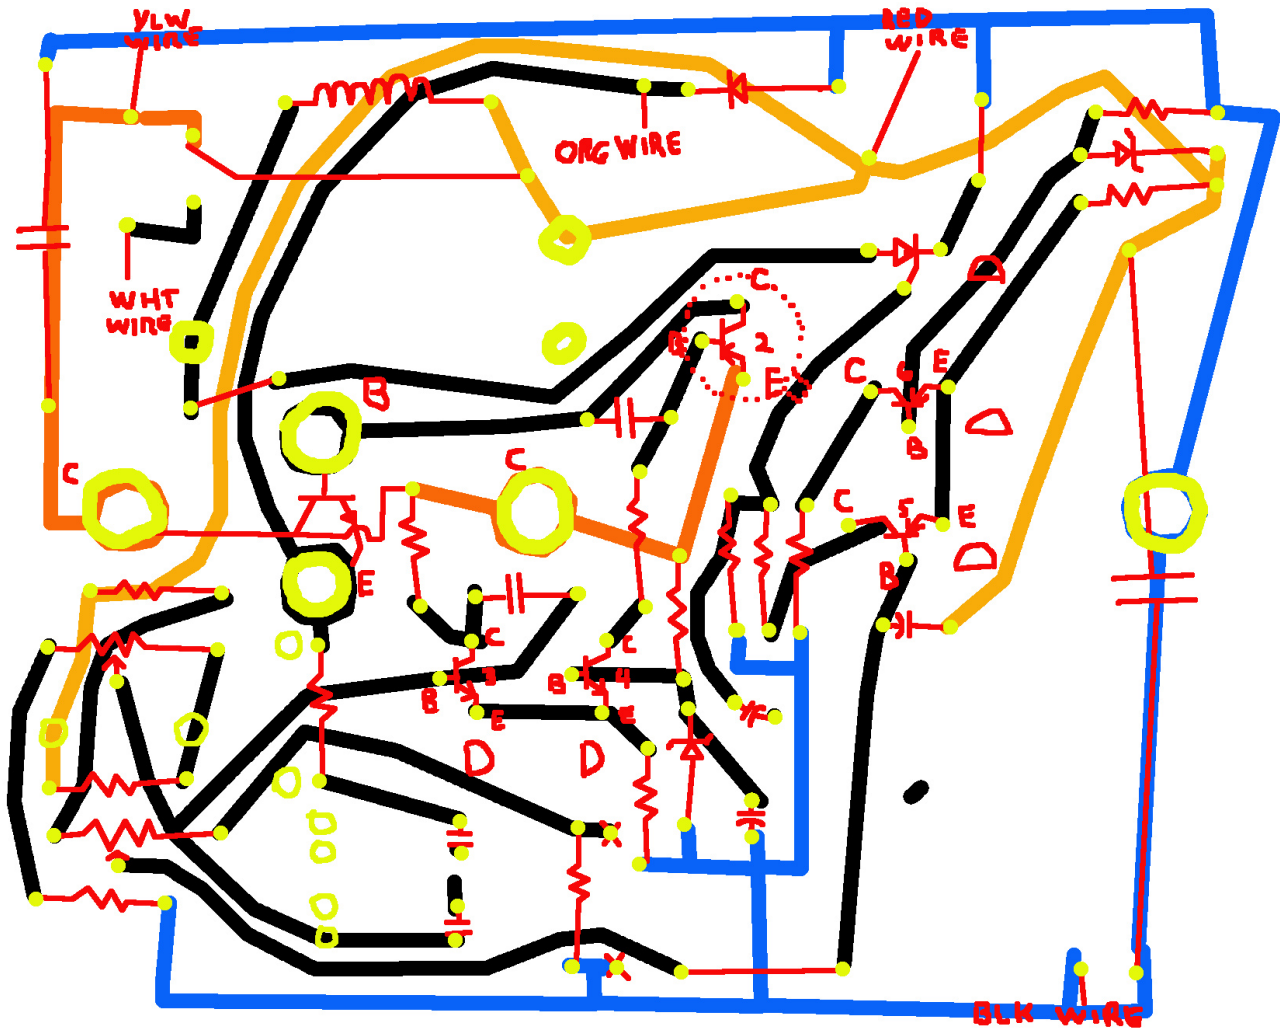
PCB traces as viewed from the backside of the board, with the components as connected on top.

Blue is the ground plane, light orange is the bus voltage trace, dark orange is the switched voltage trace. Yeah, the the traces should have been colored to be consistent with the wires connected to them, but you can't get good help these days.

The yellow wire is not on the schematic but is labeled "OV latch". It goes to pin G on the connector and is unused on the Baron.

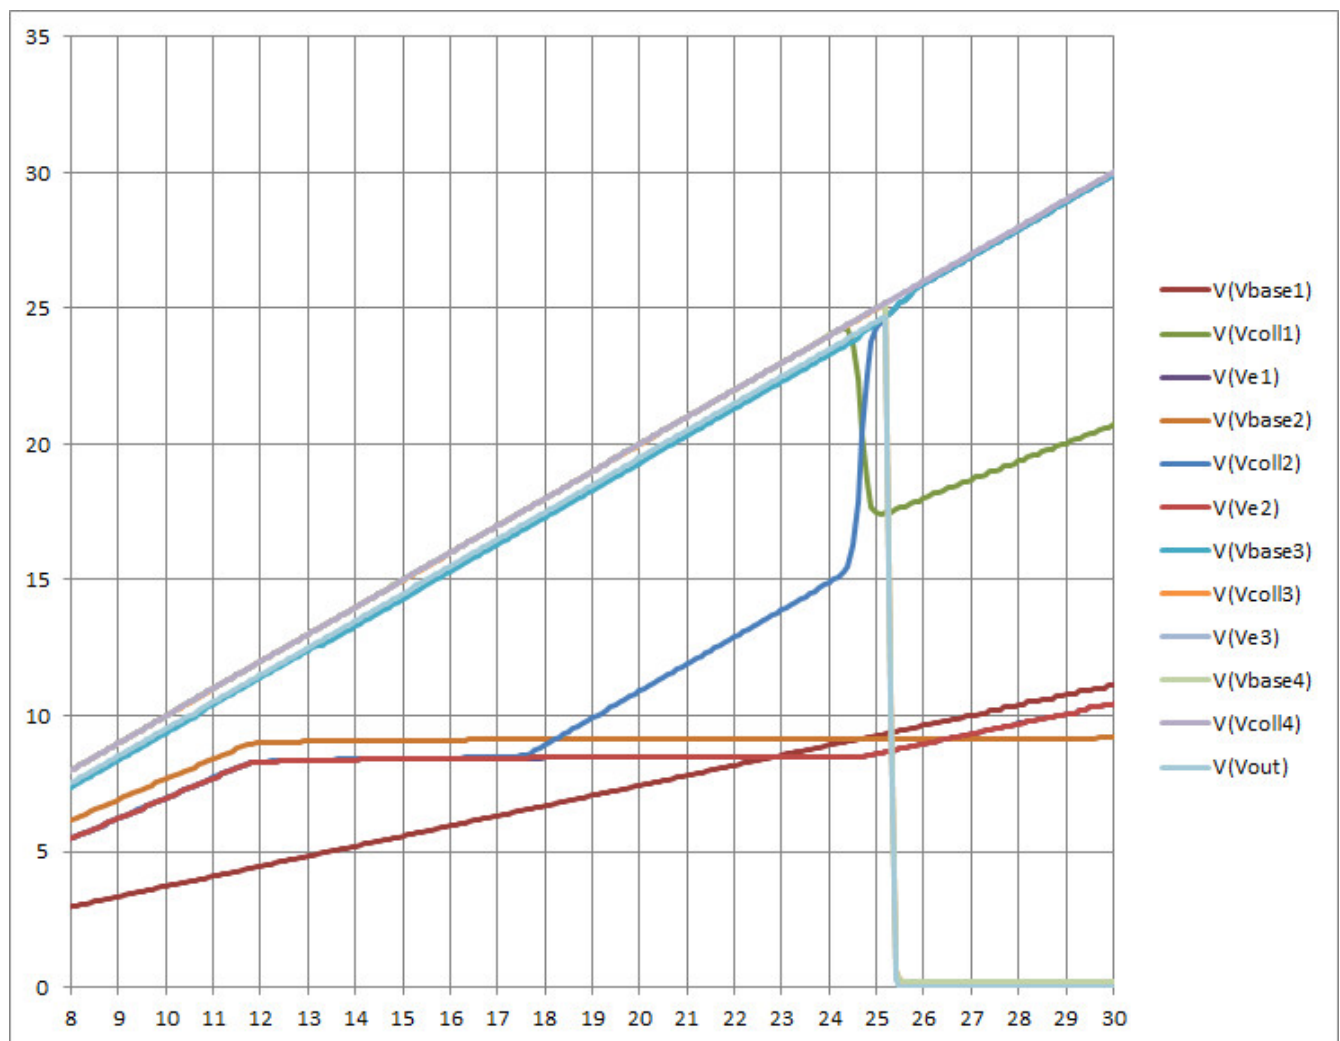
Plot of voltage traces of the regulator transistor EBCs.

The same jackwagon who screwed up the PCB trace colors also numbered the Qs in this simulation and they do not match the schematic. V1 to V4 in the plots corresponds to Q3/Q4/Q2/2N3055, respectively, in the schematic.,

The x-axis is regulator input voltage. When installed on an airplane, input voltage will not go below 24V due to the battery.

The plots shows the regulator cutting off at ~25.2V because I just lumped the trim pot and divider resistances together in the simulation. The trim pot changes the slope of the Vbase1 line (lowest line at the start) and the intersection of Vbase1 and Vbase2 normally occurs somewhere around 28.5V. In practice, the actual cutoff voltage isn't adjusted, the output of the alternator is. On the Baron, this is done with the left engine running (both VRs sit in the nose) while measuring bus voltage.

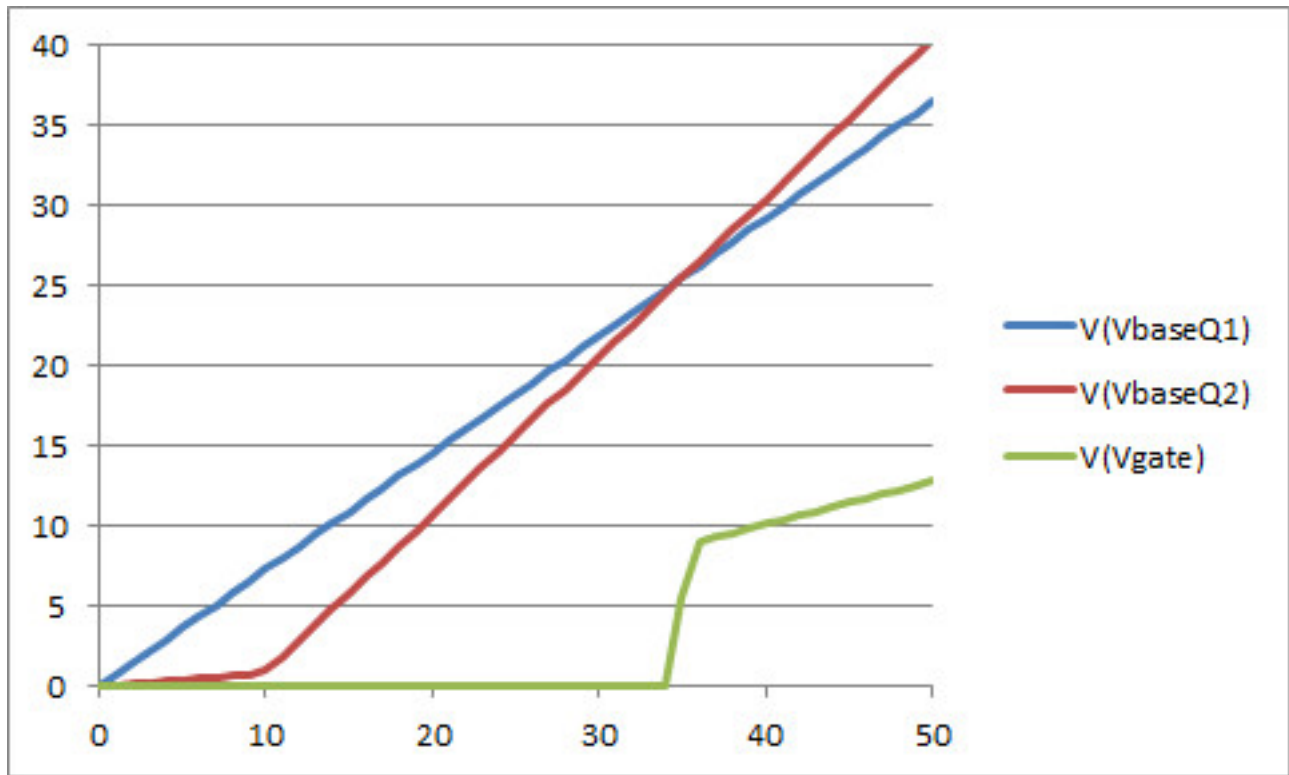
Overvoltage circuit plot of the transistor base voltages and SCR gate voltage. Q1 and Q2 in the plots are Q5 and Q6, respectively, in the schematic. As with the regulator circuit, the trim pot changes the slope of the blue voltage line, and therefore changes the intersection point of the two voltages.

I also lumped the trim pot resistance here, so the cutoff in the plot occurs at ~34V. A properly adjusted regulator will trip at 32V.

The SCR will start conducting, causing a trip-off, when the gate voltage is a fraction of a volt.
