Cabin Door Latch Adjustments...An exercise in futility!
Parvez Dara, ATP, MCFII, AGI -G36

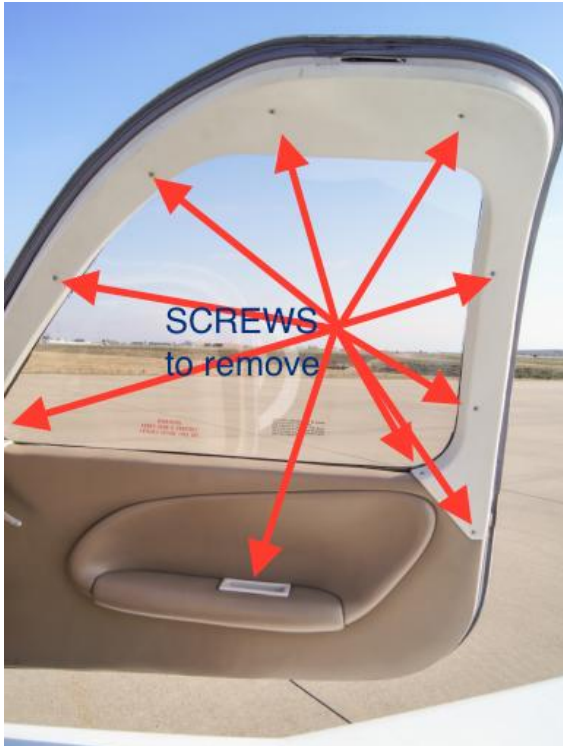
An eventful weekend before Christmas. I decided to utilize Kevin O's recommendations for laying up the outside door latch flush with the door. After removing the upholstery on the G36 (which is at best tedious for a novice attempting to be a mechanic – that is why Kevin O' admonishes to stop, I however continued to proceed. That STOP NOW part I did not heed. The Door Upholstery and the multitude of screws to remove.

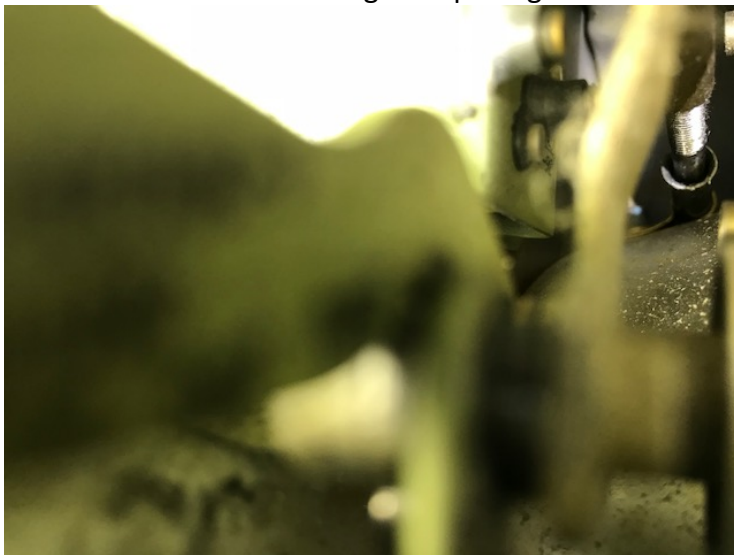
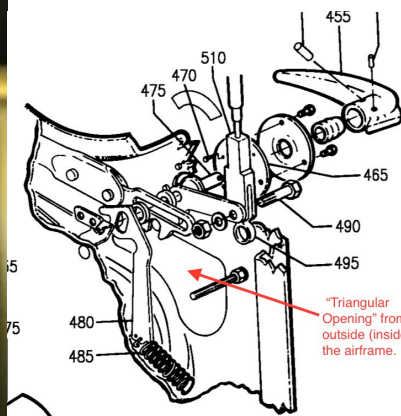
This is a view from the triangular opening...

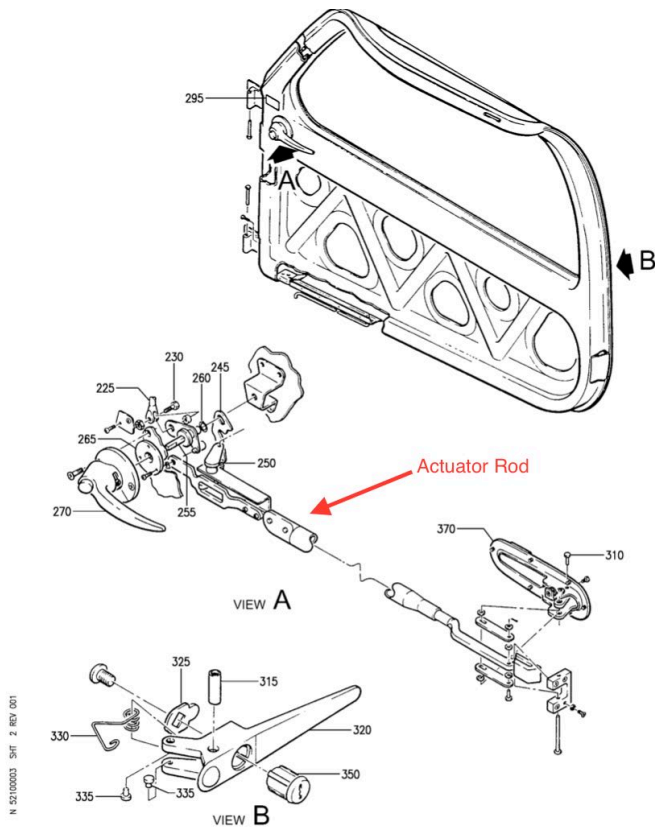
With an hour of time under my belt, voila and all screws safely stowed, the naked skeleton of the doorframe stood open for possibilities. After following the procedure to the tee, and the "keeper" stowed, the actuator rod finally came off the bolt knob (1 hour later). What a relief. I was making headway.

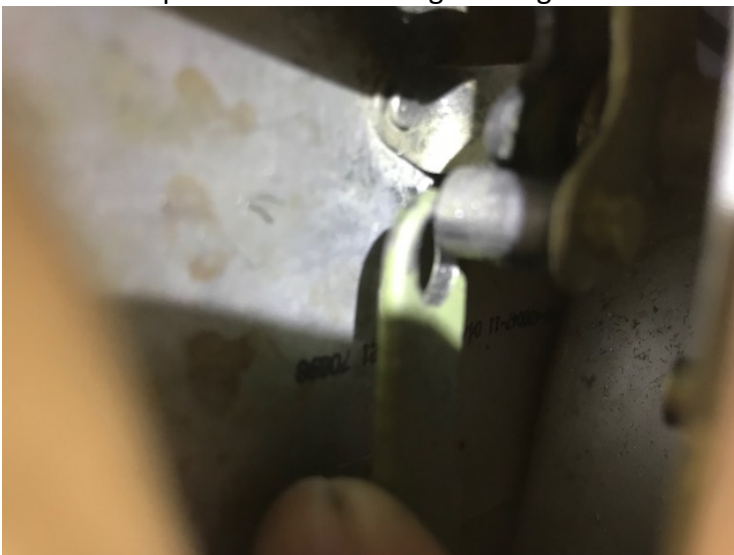
Lo and behold the actuator rod would not place itself onto the bolt knob. I could see it through the “triangle” but all unforced and forced effort failed. There was a ¼ cm distance between seating and non-seating and I could not seem to overcome that, however hard I tried. Ugh!

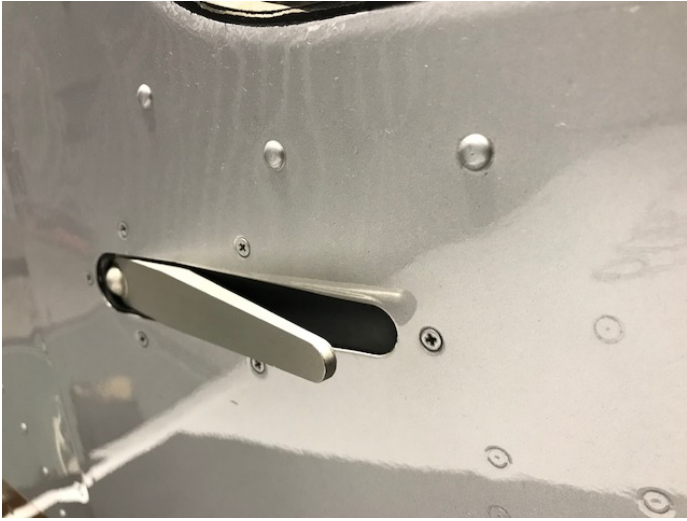
And so was the outside latch sticking out for clear air like the pitot tube. If Beech could only put a couple of holes in the tip, maybe a redundant...never mind.
