**MIKE BUSCH**

# Cylinder Work: Be Afraid

It is nearly impossible to install a cylinder properly when the engine is on the airplane

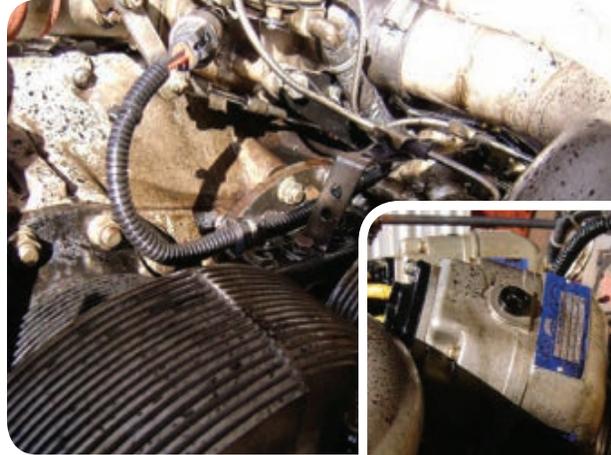
*This Continental IO-550 threw the No. 2 rod through the top of the case less than 10 hours after the No. 2 and No. 4 cylinders were replaced at annual.*

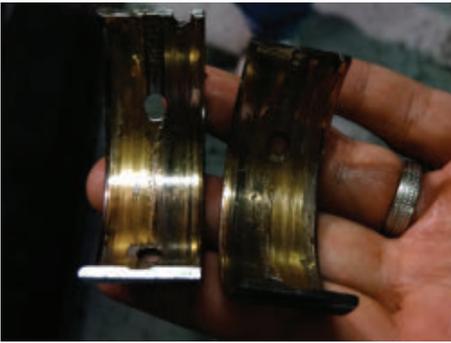
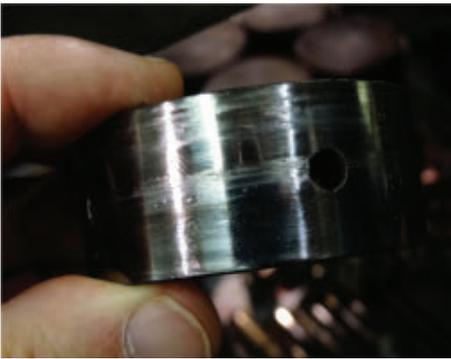
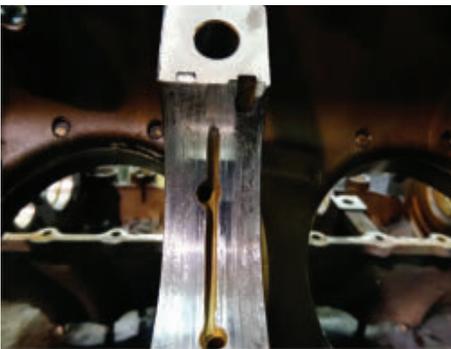
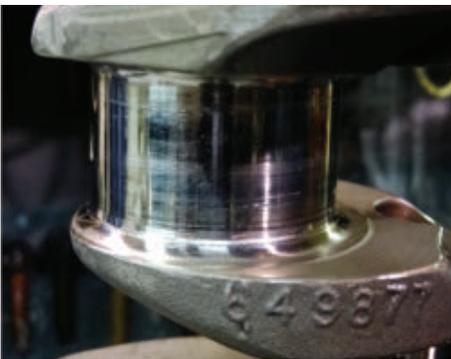
*This Continental IO-360 spun a main bearing after cylinder work. Fortunately, the situation was caught at a routine oil change (where the filter was found to have thousands of flakes of bearing metal) literally an hour or two before the engine would have self-destructed in flight.*

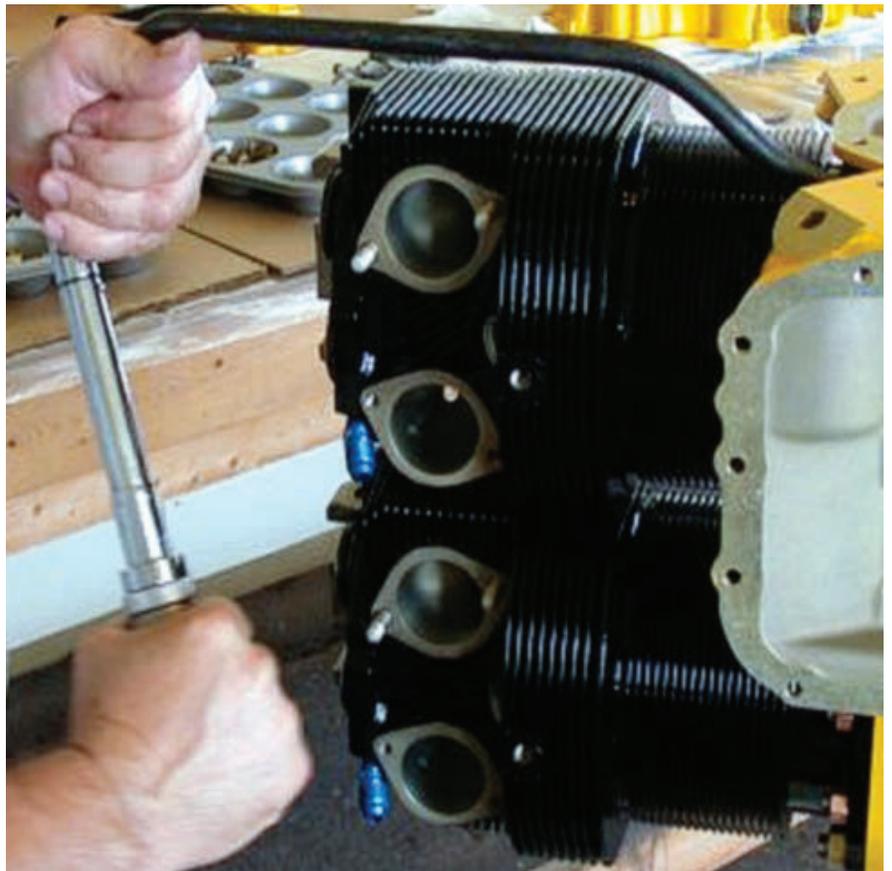
*Achieving final torque needs to be accomplished with one smooth motion of the torque wrench. This is usually possible when the engine is out of the airplane and being assembled on a stand, but it's almost impossible when the engine is in the airplane.*
