# **THE TECHNICIANS NOTEBOOK**

**By Jerry Gordon**

## The Technician's Notebook Table of Contents

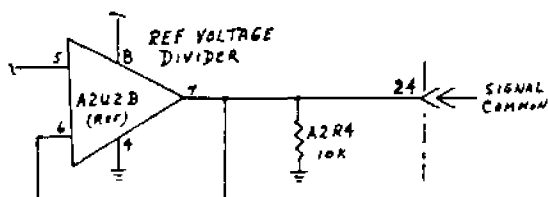
**AV80-34 Power circuit improvements.** Tech Aid No. 108 Installation of 10k resistor (PN 003410103) A2R4. If A2U2 is replaced on any CA-395A, A2R4 should be installed if it is not. Verify that capacitor A2C6 has been deleted as per Tech Aid No. 74. If not remove and discard. Install A2R4 as per drawing.

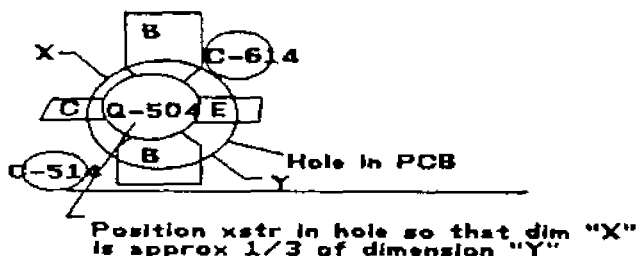
In light of this restriction and due to the limited to no availability of the MSC80377/SRF2848 device, the MRF 1150 is now being used in current production and is substituted as a replacement for Q504 under the same part number 352-5057-010.

This device, when mounted as shown, is capable of producing from 90 to 115 watts in the TCR-451 transmitter.

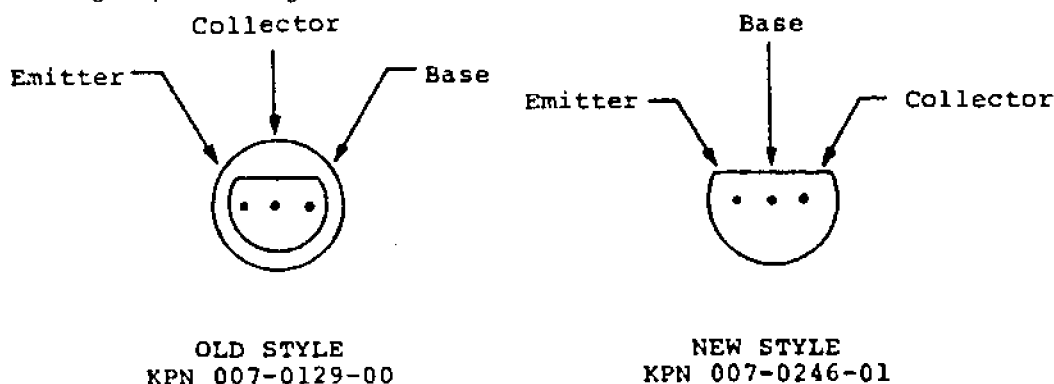
**KMA 20-101** Change of transistors Q-115, Q-116, and Q-117 to new type. The new transistor (007-00246-0001) is a SPS6830 NPN Darlington with a higher power rating.
