American Bonanza Society Air Safety Foundation Landing Gear Inspection Checklist

For Beechcraft Bonanza, Debonair, Baron and Travel Air

Landing Gear Inspection Checklist Amplification

Landing Gear Repair Guide

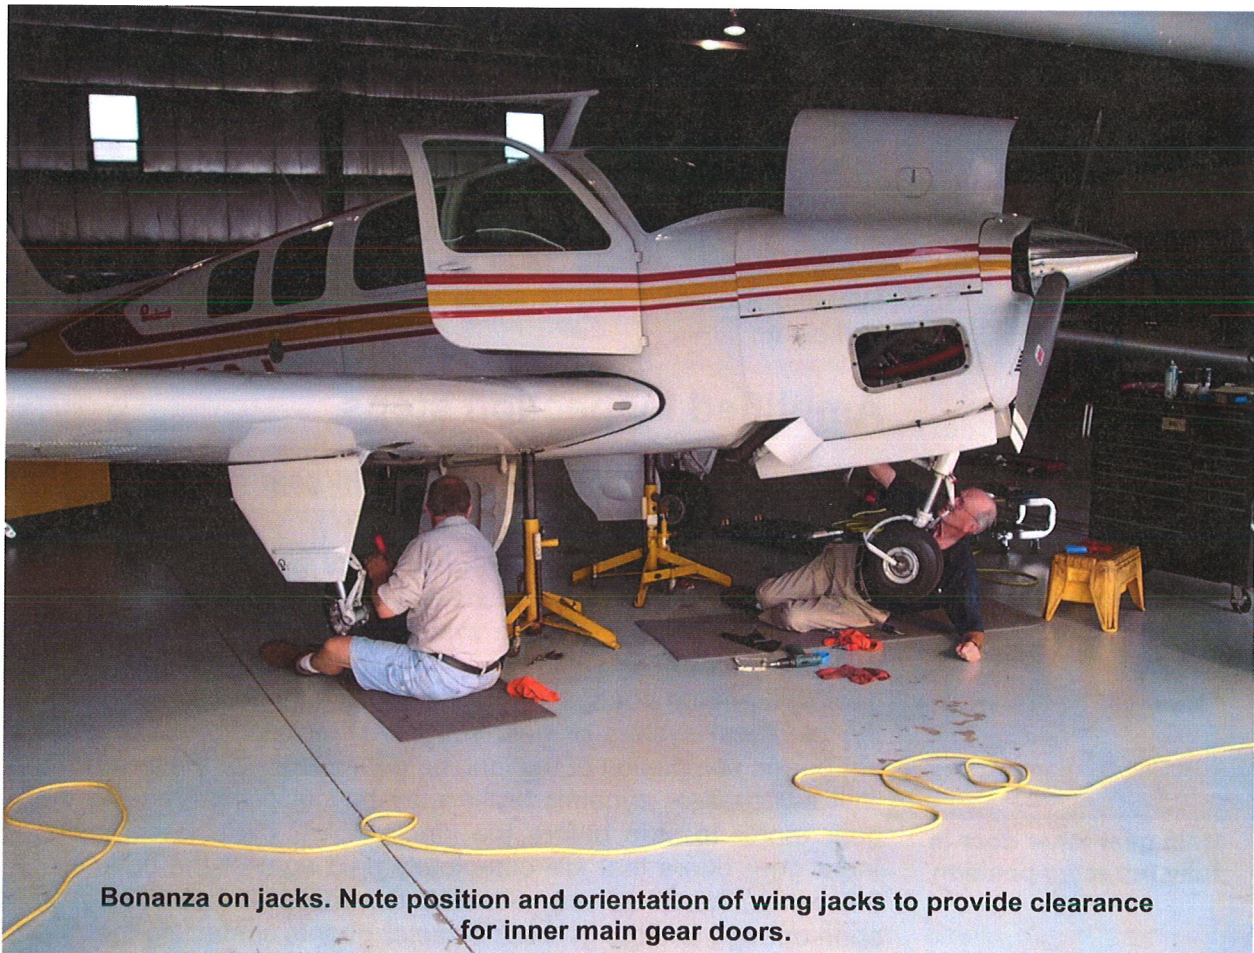
Bonanza on jacks. Note position and orientation of wing jacks to provide clearance for inner main gear doors.

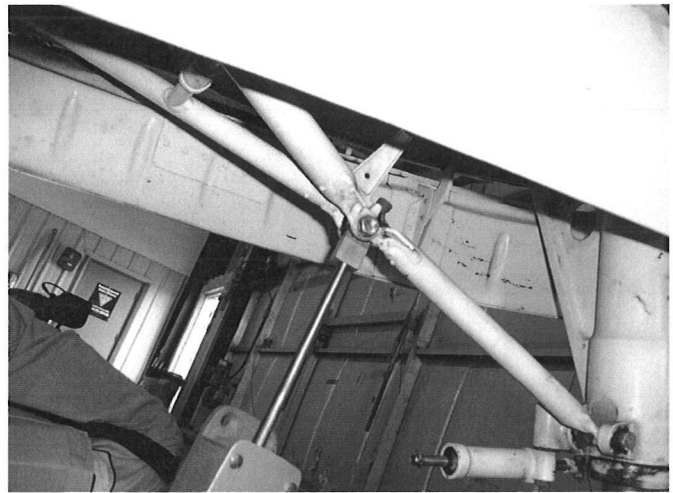
Checking the nose gear down tension with a mechanical push-pull force gauge.

Using a calibrated mechanical or digital push-pull force gauge, push on the knee joint of the lift leg and check the force required to deflect the joint. Record the results of all three landing gear and compare them to the tolerances listed by model in the maintenance manual. Note: keep push-pull force gauge approx. 90 degrees to lift leg when performing this check. On twin-engine aircraft equipped with the positive downlock mechanism, this system must be disconnected in order to perform a main gear down lock tension check.

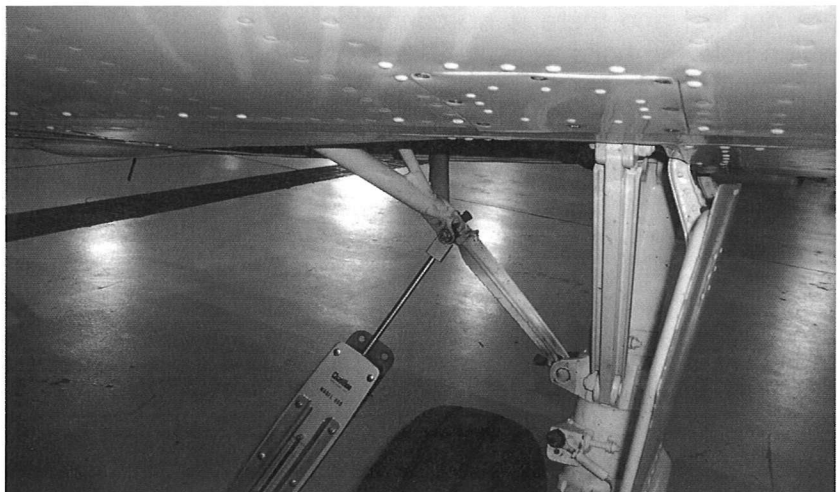
Checking downlock tension on the main landing gear.

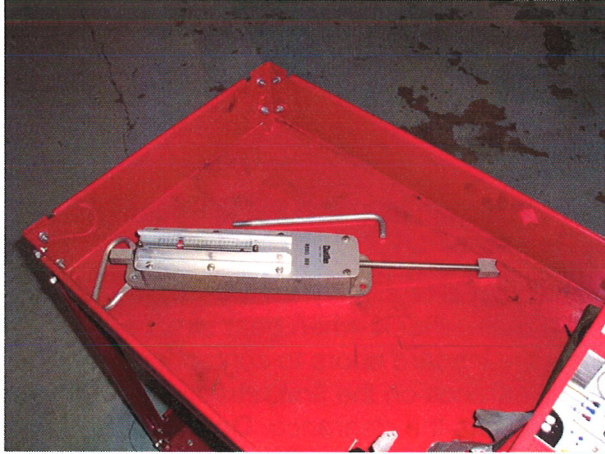
Chatillon Model 80D mechanical push-pull force gauge. This commonly used gauge is no longer in production.

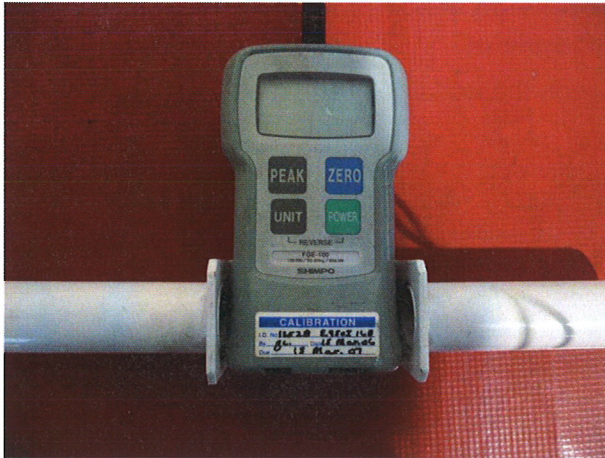
Shimpo FGE-100 digital push-pull force gauge. Note there are several models of push-pull force gauges that can be used.

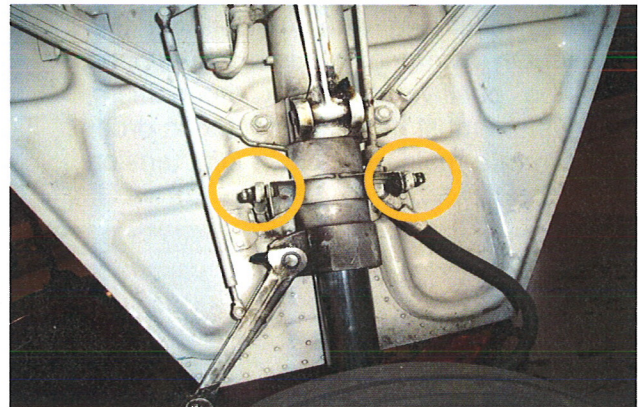
Outer gear door disconnect points

Leave the outboard gear door hanging loosely to provide access for the inspection.

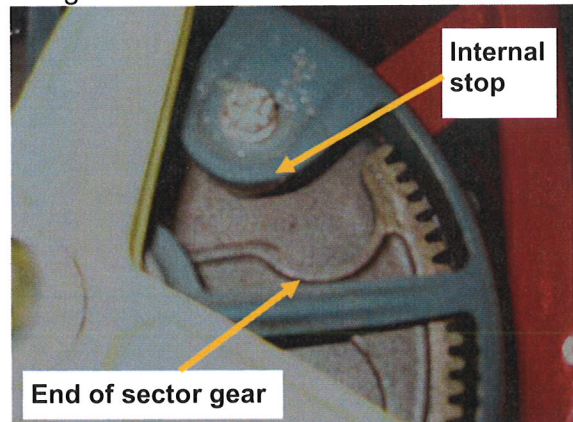
Cutaway of a gearbox showing the sector gear approximately six turns of the hand crank from the end of cycle, but not contacting the internal stop.

If the handcrank has less than these turns remaining with the gear down under normal circumstances, the dynamic brake may not be stopping the gear motor in time to prevent the gear box from contacting an internal stop at the end of the extension cycle. This in turn can cause the gearbox's sector gear to bend, crack or fail. If the handcrank turns too far in this condition, the gear motor and/or dynamic brake may be stopping the gear before it is fully locked down. This risks a gear collapse. This condition may also be indicated by an inner main gear door or doors that do not fully close. **STOW THE HANDCRANK.**

Note: If the sector gear hits the stop in either the extended or retracted position, the gearbox and motor should be removed and overhauled. The most common cause of this condition is a gear motor that is overdue for overhaul. If the motor's brushes are worn, springs are weak or the commutator is dirty or worn the motor will not stop instantly and will drive the sector gear into the stop. Do not attempt to replace motor brushes in the field. Brushes need to be run in for good brush contact with the commutator and provide proper dynamic brake operation. Send gear motors to a qualified shop for overhaul.

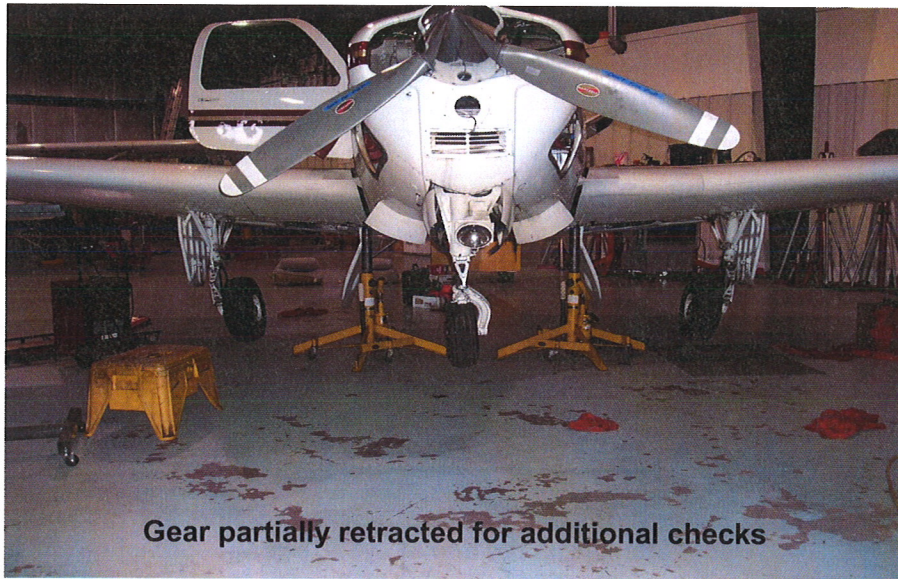
10. Check for lift leg joint play.

With the gear at mid-extension, check each wheel for play by grasping each tire and wiggling it. It's okay to feel some play, but you should not be able to see any.

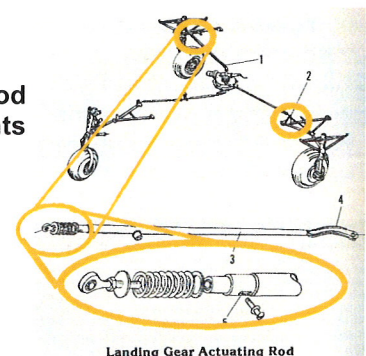
Retract rod slip joints

While pulling the main wheels toward the fuselage, check that the retract rod slip joint springs compress.

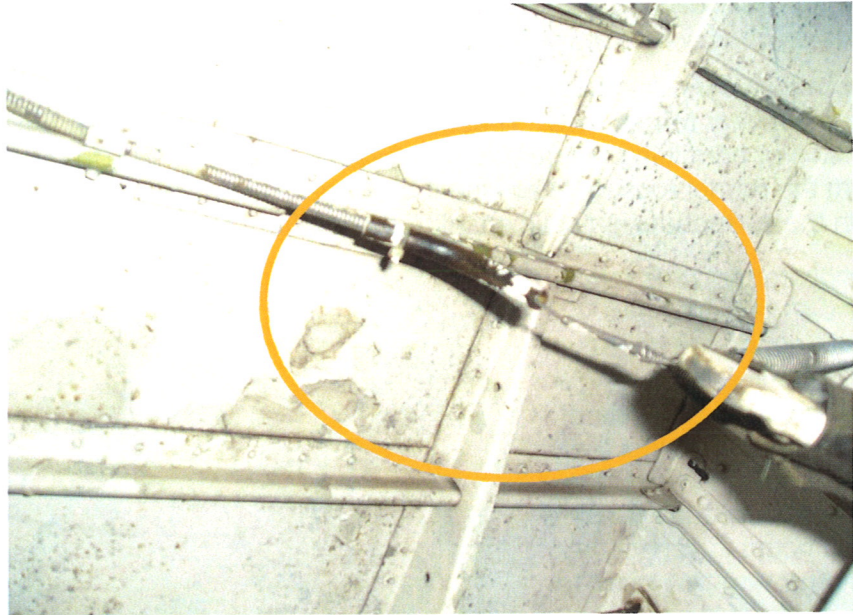
Check the uplock springs for corrosion.

Check the holes in the uplock bracket and the spring attach holes are not elongated or corroded.

Cable and Tygon tube

Canvas boot

Uplock springs

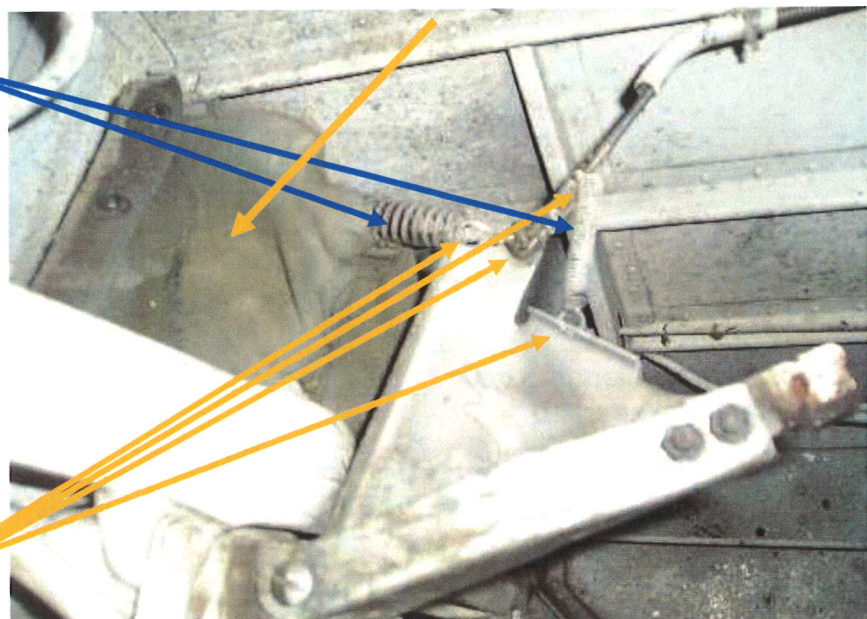
Attach holes

Note: The protective canvas boot has been removed from the uplock for the inspection

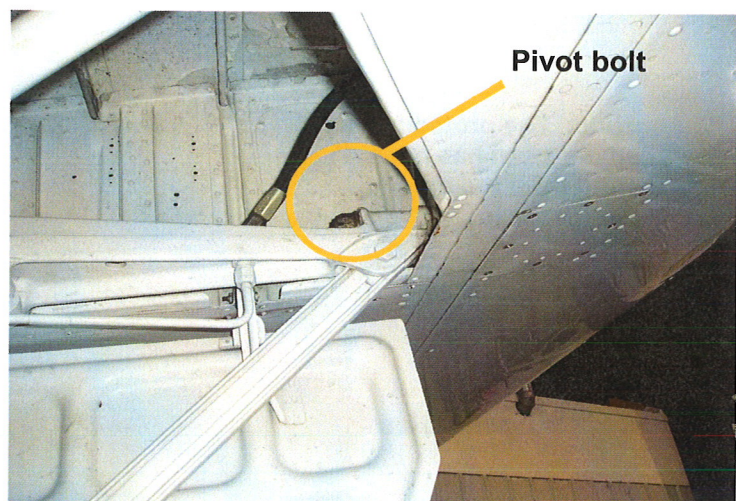
15. Check the pivot bolts that attach the main landing gear struts to the spars.

Use a wrench to check that the bolts do not rotate.

The strut should rotate on the bushing without bolt movement.

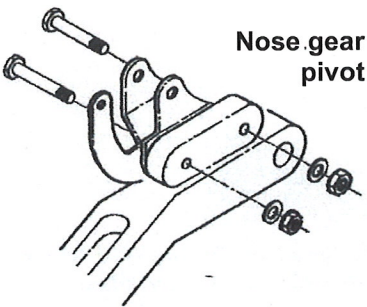
Nose gear pivot

On aircraft with the aluminum forging lift leg, check the right side of the nose gear pivot for movement where the inboard and outboard arms are bolted to the forging. Place a finger on top of the lift leg and press against the inboard arm while moving the nose gear slightly fore and aft. There should be no movement between these parts. Any movement here will cut down on nose gear tension.

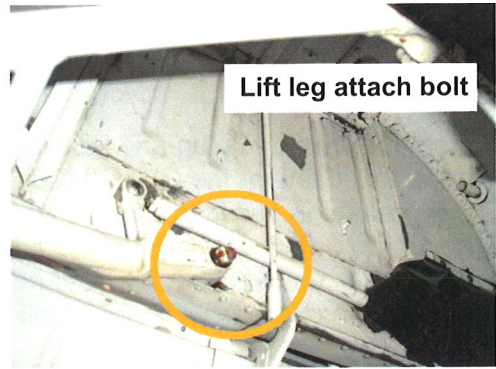
Lift leg attach bolt

Use a wrench to check the nose gear lift leg attach bolt for looseness.

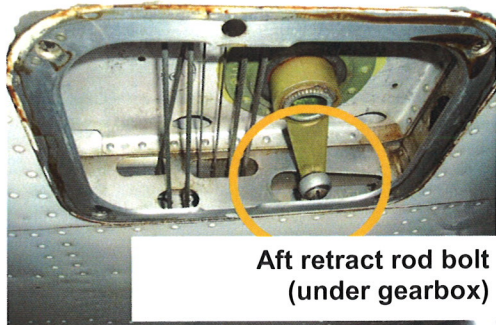
**Aft retract rod bolt
(under gearbox)**

Check the nose gear retract rod at the underside of the gearbox. While pulling the nose strut aft slightly to unload the nose gear, you should not be able to turn the bolt with a screwdriver. The bolt should be installed so the head of the bolt is down. Check for excessive wear between the nose gear actuator arm and the splines. Check for gearbox oil leaks.

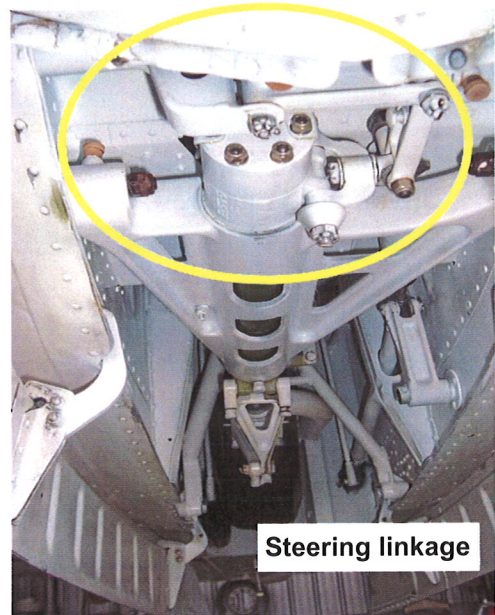
Steering linkage

Check the nose gear steering linkage for security and any damage.

There is a roller bearing in the nosewheel centering mechanism on the upper, aft side of the strut. Check that this bearing is able to rotate.

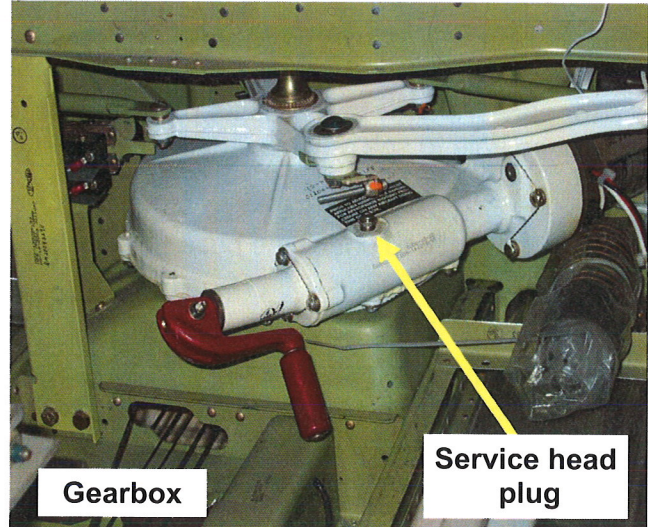
Remove the head plug and look into the gearbox. Confirm the GEAR MOTOR circuit breaker is pulled and turn the manual handcrank. The worm drive should just barely pick up fluid as it turns. If needed, service the gearbox with 636 Mobil or Mobil 1 oil.

A common indication of an over-serviced gearbox is leaking fluid on the cabin interior below the landing gear emergency handcrank.

It takes only eight ounces of fluid to fully service a completely empty gearbox.

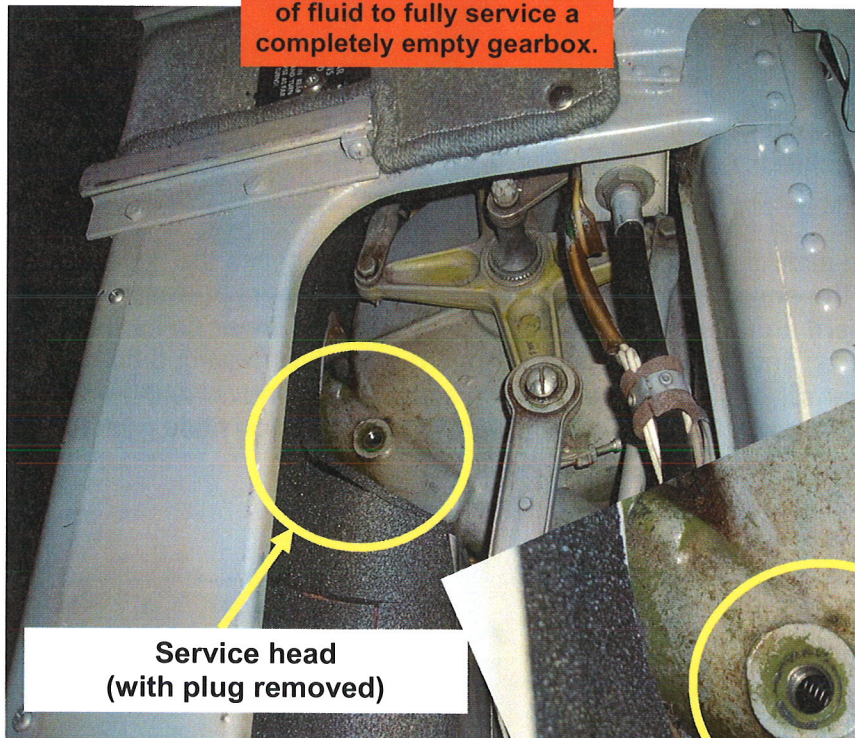
Looking down at the gearbox, beneath the copilot seat

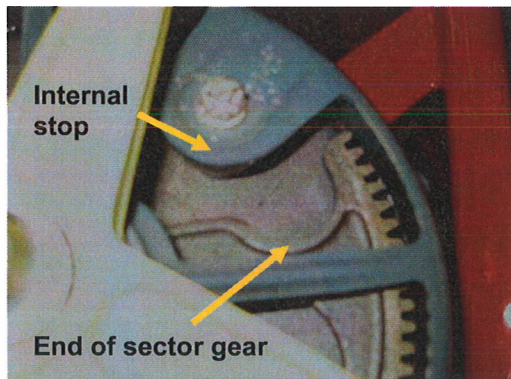
Sector gear near but not contacting the internal stop.

Gearboxes originally painted green should have 1/8 to 1/4 turn tolerance and gearboxes originally painted white should have 5/8 to 3/4 turn remaining at the end of electric travel. Many airplanes have been retrofitted with earlier or later gearboxes, and many originally green gearboxes have been erroneously painted white when overhauled.

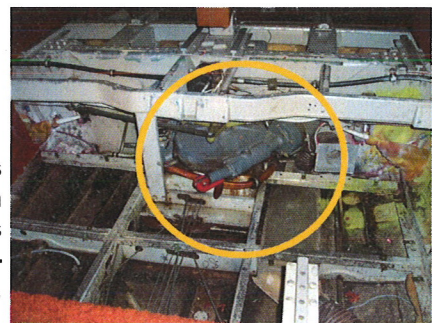
Some gearboxes may have been painted other colors when new or overhauled.

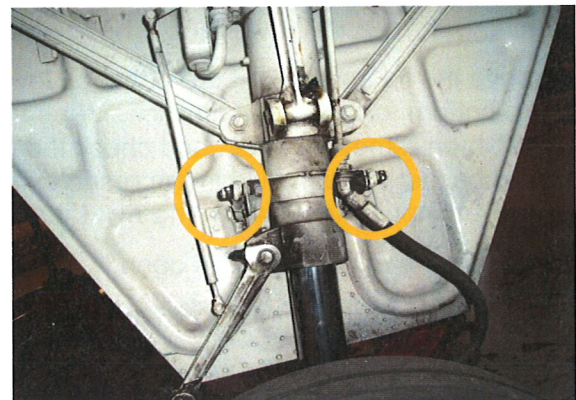
Outer gear door connection points

To reconnect the outer door the hardware sequence is: Both fore and aft bolt heads face the strut. The forward connection is bolt through the bracket, two washers, the link rod end, one washer and the nut. The aft connection is the bolt through the bracket, one washer, the link rod end, one washer and the nut.

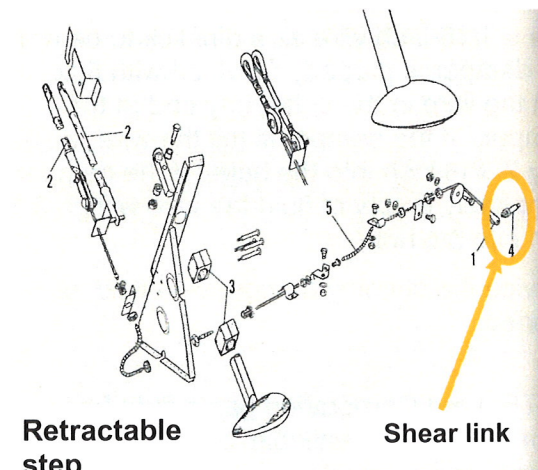
Check that the shear link is installed and is intact.

Retractable step

Shear link

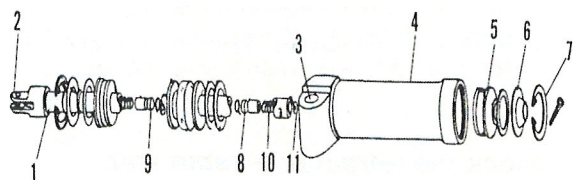
Shimmy damper

The shimmy damper should have no play, and show no sign of leaks.

NOTE: Lord Corporation has a fluid-free shimmy damper available for installation on all models under an STC.

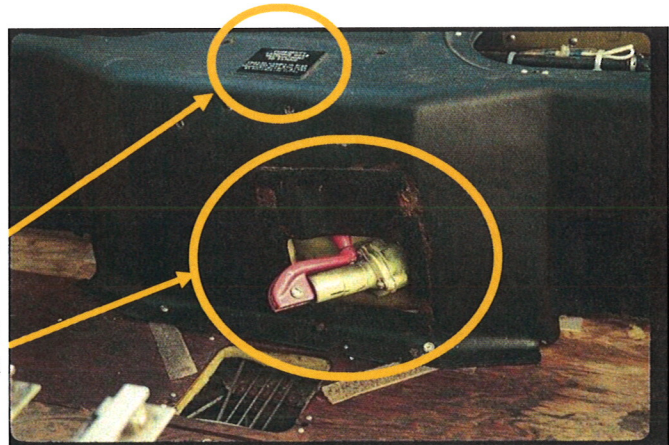
Improperly installed spar cover and obstructed handcrank

It is quite common that mechanics install the forward spar cover (in later models) so that the hard plastic covers the stowed landing gear emergency handcrank. The plastic is very hard and tolerances in this condition very tight. It is not possible to unstow the handcrank in this condition, so it would prevent a manual landing gear extension in the event the gear could not be extended electrically.

38. After the cabin inspection is complete, ensure the manual extension handle is stowed and it is not blocked by the spar cover. Install the protective boot or cover.

The protective boot or cover helps keep the handcrank stowed when passengers or baggage might otherwise contact the handcrank and cause it to come unstowed. This in turn can cause the handcrank to bind against something when the gear is run electrically and the engaged handcrank turns. It is possible to strip out the handcrank connection or damage the gear motor if the handcrank meets resistance.

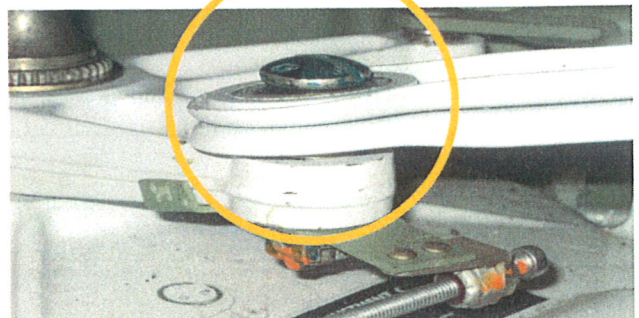
Retract rod attach bolts can work loose and elongate the mounting hole in the gearbox top actuating arm.

1. Pull the landing gear motor or relay circuit breaker.
2. Crank the landing gear up 20 turns from the down position to release the tension on the gear. Stow the emergency gear handle (NEVER leave the handle engaged).
3. Check that the main gear retract rod attach bolt is tight at the actuator arm. Using a large standard screwdriver try to rotate the attach bolt without the weight of the main landing gear preloading the retract rod. Have a person lift up on the main wheel to remove the weight on the rod and attach bolt.

1. Main landing gear retract rods, loose attachment hardware at the upper gear actuator retract arm (continued).
 4. If the bolt is discovered loose, remove it and inspect bolt hole in the actuator arm for elongation. If good, reinstall the bolt, tighten to a standard torque for a shear nut, and safety. If the bolt hole is elongated replace the actuator arm. The bolt should be inspected for wear and replaced if worn.

Note: The main gear may be sagging off the up stop in the up position if the attach hardware is loose.

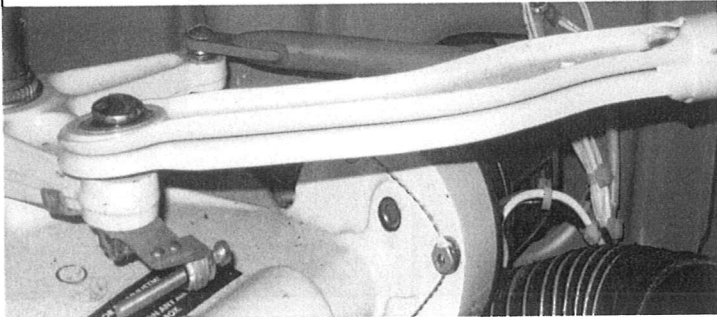
Flat area of the retract rod

1. Inspect the flat area of the retract rod for flexing up or down. Preload the rod by lifting the main wheel and collapsing the plunger on the outboard end of the rod, or watch the operation of the rod during an extension cycle for flexing. A frozen plunger may cause this problem.

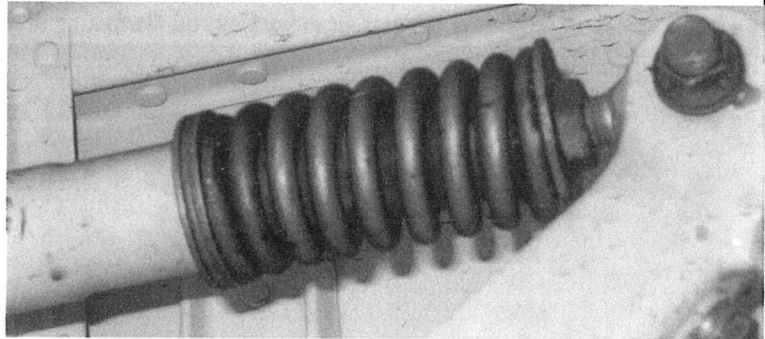
Retract rod

2. Tighten the jam nut and recheck down tension. Check that the retract rod is free to rotate. The left-hand rod has slightly more rotation than the right-hand rod, but they should both be free to rotate. If they don't, the rod itself will twist.

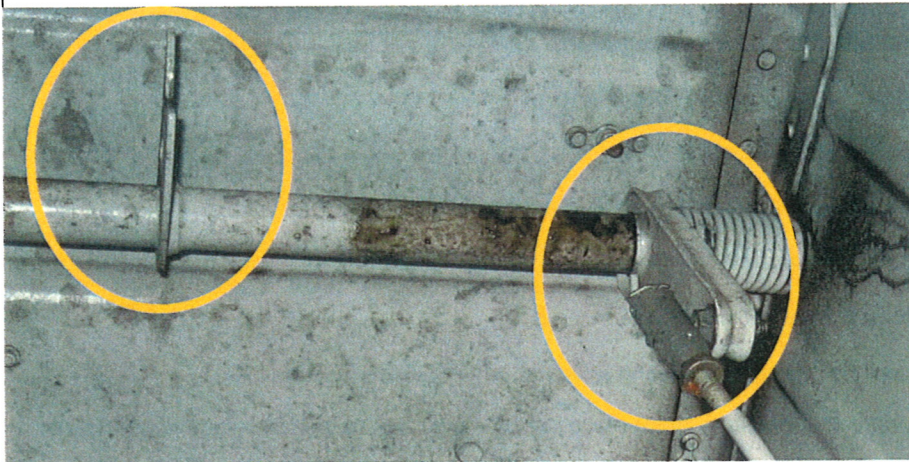
Nose gear door actuator arm (right) and door actuator pin guide (left)

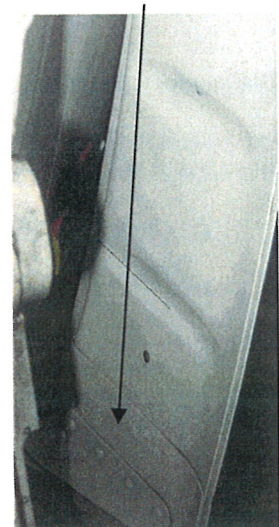
Repair doubler

1. Check the nose gear door actuator guide, especially the upper side of the guide, for cracks or to see if it is broken off. Lubricate the guide with a light grease to reduce wear on the guide and on actuating pin.
2. Check for damage on the door actuator pin.
3. On single-engine airplanes with cowl flaps, check for wear on the cowl flap actuator cross-shaft bearing plates at the ends of the shaft, attached to the nose gear tunnel. The nose gear door actuator rotates on this shaft. Excessive wear on the bearing plates can create alignment problems with the guide and pin.
 - (1) Replace worn bearing plates.
 - (2) Grooves worn in the shaft may be welded and then lathed to shaft diameter.
4. Cracks aft of the forward door hinge on the inside or the door may be repaired with a doubler, structural adhesive and blind rivets.

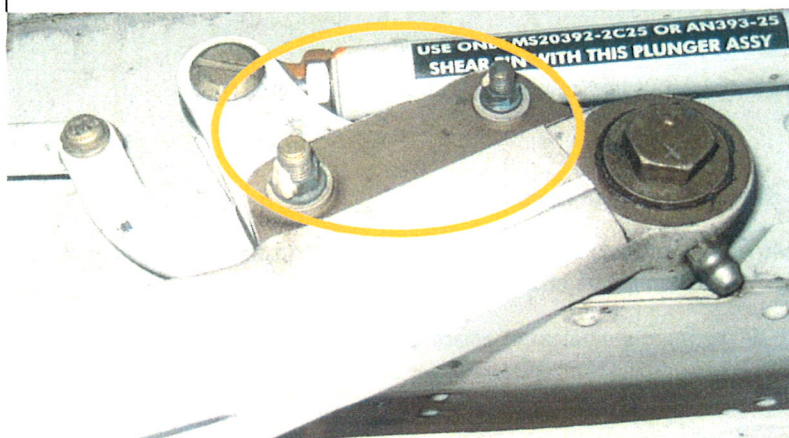
Retract rod mounting bolts

Beechcraft recommends a 2,000 hour inspection of the two (2) bolts and two (2) drag brace brackets. (NOTE – the Illustrated Parts Catalog refers to the brackets as inboard and outboard arms.)

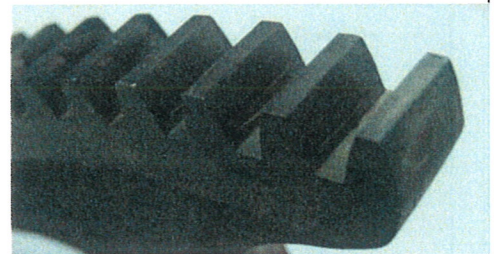
Worn gear teeth

(2) ABS recommends non-destructive inspection (NDI) of the gearbox parts when overhauled. Inspect sector gear teeth engagement to the worm drive gear at both ends of the gear. Sector gear teeth become compressed (closer together) from hitting the stop. The gear will show signs of metal trimmed off of the lands of the teeth and will not fully engage the worm gear. Sector gears that do not fully engage the worm gear teeth need to be replaced.

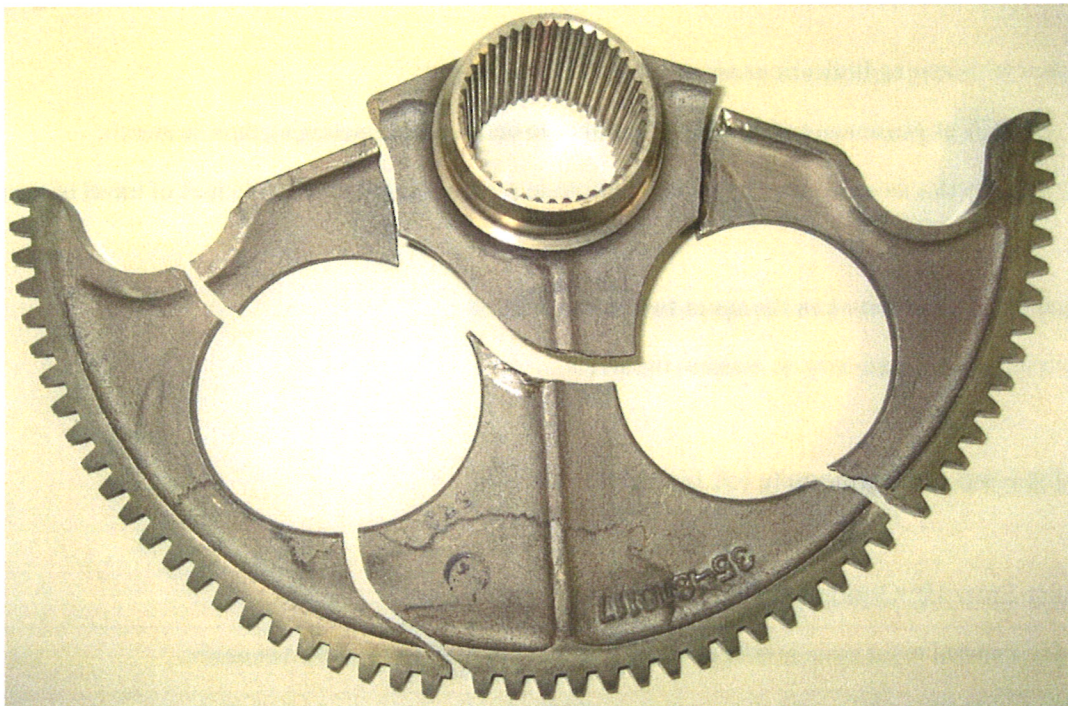
The sector gear from a 28-volt airplane that hit the internal stop on both sides repeatedly for a long period of time. The sector gear became work hardened and brittle, and eventually shattered.

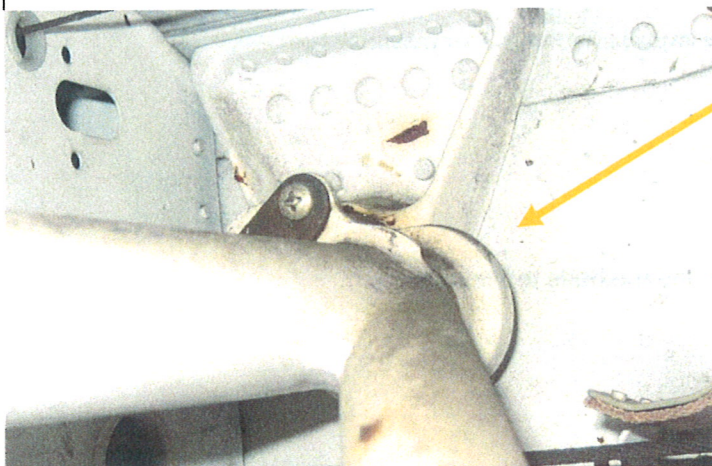
Mounting boss and lift leg bushing

- (1) Check the mounting pin for wear.
- (2) If the pin is good, replace the bushing.
- (3) If the pin is worn, replace the pin and the bushing.

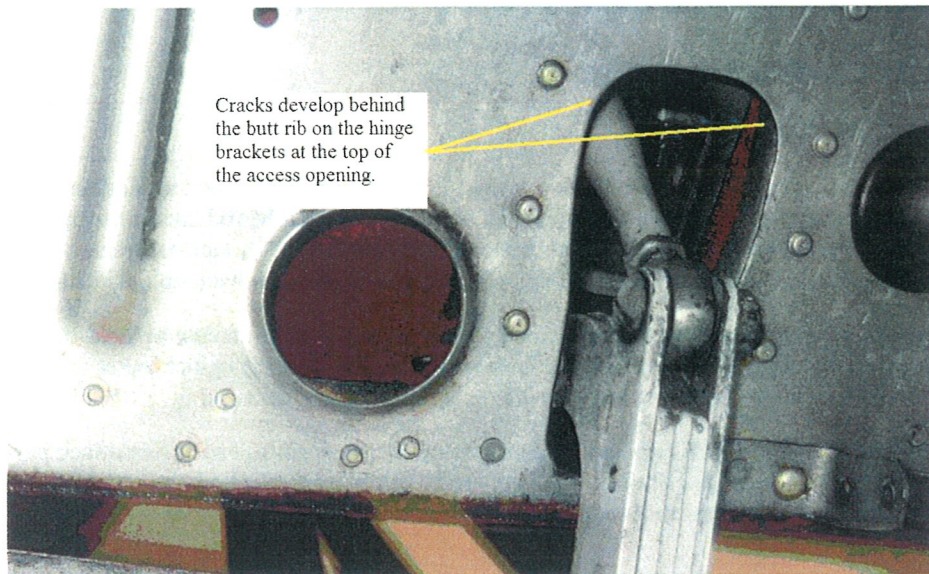
Forward hinge brackets will crack occasionally on the forward and aft sides of the access hole. You may have to remove the lower wing root fairing for access.

- (1) Manufacture a small doubler with a 90-degree angle to reinforce the bracket.
- (2) Install doubler with structural adhesive and rivet to the butt rib with Cherrymax-type blind rivets.

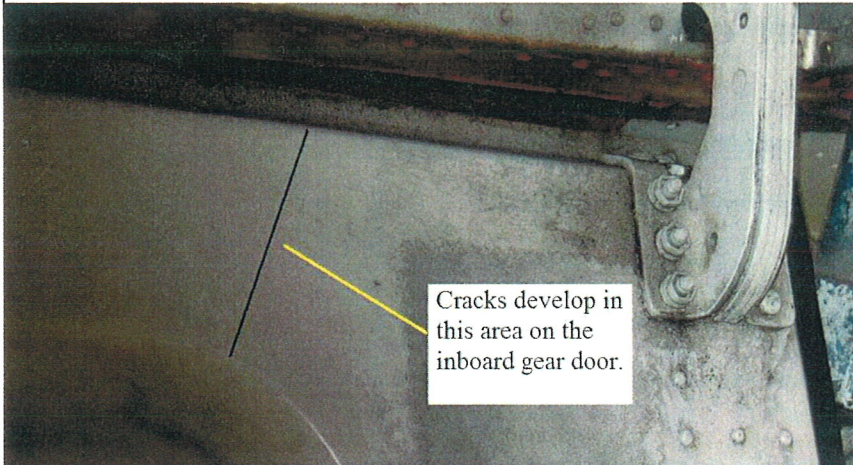
Discrepancy: Main gear inboard door cracks

A locally manufactured doubler (this may take some craftsmanship) installed with structural adhesive and blind rivets makes a good repair. Use scrim cloth with the adhesive.

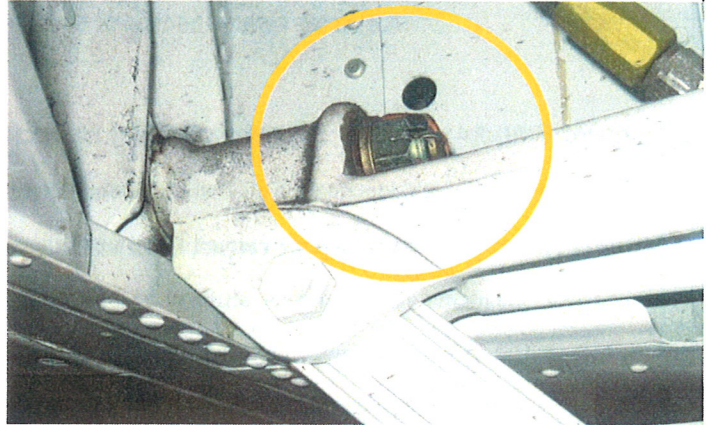
Pivot bolt

- (1) Remove the cotter pin.
- (2) Back the nut off until it is even with the end of the bolt.
- (3) Apply penetrant oil and allow the oil to soak in for a period of time.
- (4) Tap the end of the hinge bolt with a light hammer. Ensure the nut is backed off and to prevent mushrooming the end of the bolt. If this will not free the bolt using an impact gun (rivet gun with flat set) set to low pressure may be required to free up the pivot bolt.
- (5) Replace the bolt if corrosion is present.
- (6) Install the bolt and bushing.
- (7) Check strut endplay and shim if required to .016 clearance between spar fitting and strut, per instructions in the applicable Maintenance or Shop Manual.

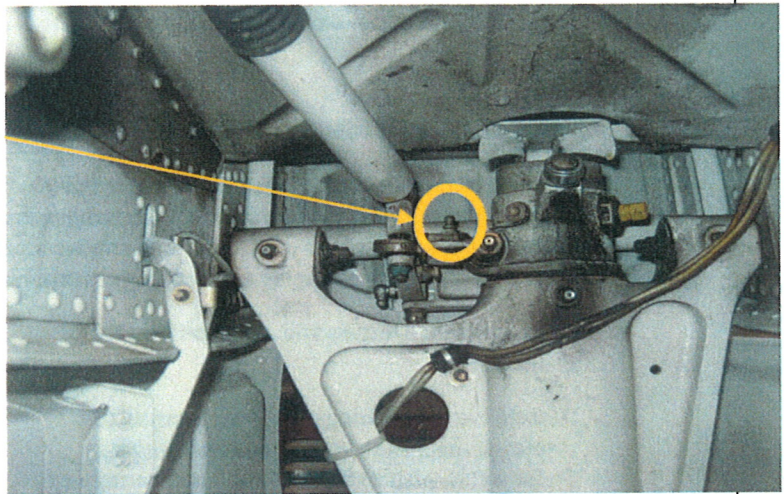
Top of the nose gear strut. Note the grease fitting is installed incorrectly, a common mistake. The fitting should be installed pointing *down* to avoid interference during gear transit and to facilitate greasing.

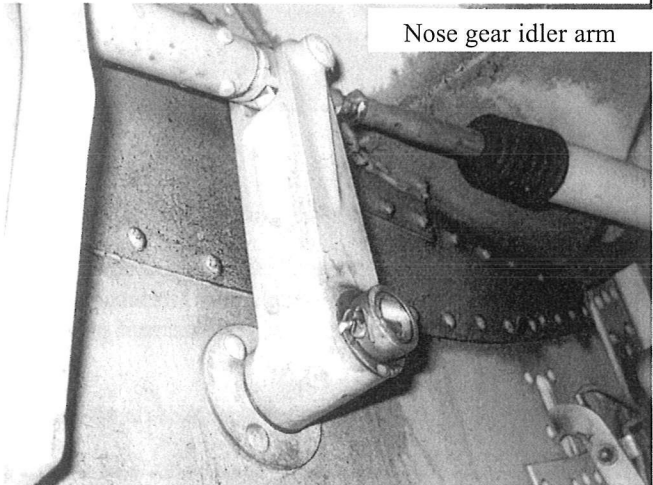
Wear occurs on the retaining collar, bushing, and idler arm shaft. A clevis pin holds the collar in place. Every time the steering linkage moves the idler arm fore and aft the arm experiences a side load as well. This can elongate the collar mounting hole. Replacing worn collars reduces bushing wear. Excessive left/right movement of the steering rods at the idler arm upper bolt may be because the two bushings that prevent side-to-side motion are missing from the bolt.

- (1) Remove the steering rod attach bolt on top of the arm.
- (2) Remove the bushings in the aft steering rod clevis. Inspect the clevis end and bushings for wear. Inspect the LS4 rod end bearing in the forward steering rod aft rod end for wear. Worn LS4 bearing can be replaced in the rod end.
- (3) Remove the retaining collar and idler arm from the shaft. Use a new bushing to press out the old bushing, then install the new bushing. Inspect the idler arm mounting shaft for wear.
- (4) Reinstall arm on shaft, replace collar if clevis pin hole is elongated. Reinstall steering rods.

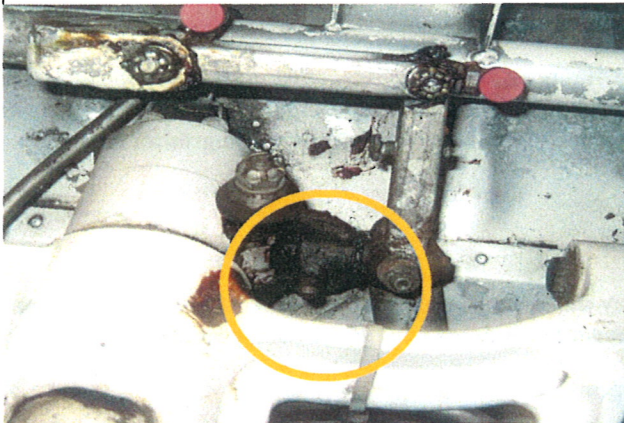
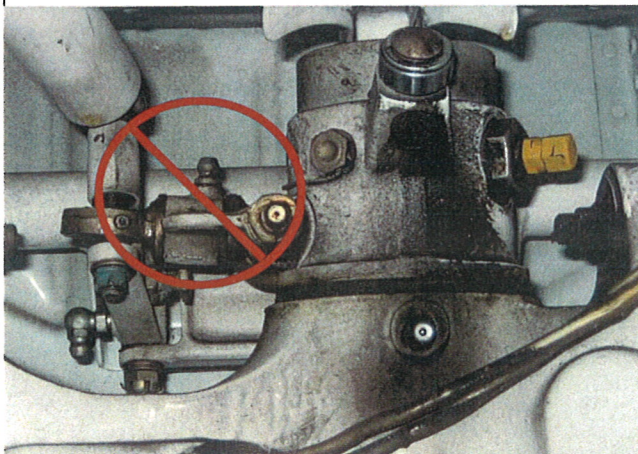
(above) Properly installed grease zerk, pointed down.

(below): Improperly installed grease zerk, pointed up.

- (1) Remove the steering yoke from the strut cap.
- (2) Support the yoke in a bench vice.
- (3) Break off the pressed-in grease fitting (P/N 1736).
- (4) Use a pin punch to drive the remaining section of the zerk through the bushing.
- (5) Use a new bushing to push out the old bushing, then install the new bushing.
- (6) Drill a grease port in the bushing and press in new grease fitting. Install the yoke with grease fitting down to prevent interference when the gear is in transit.

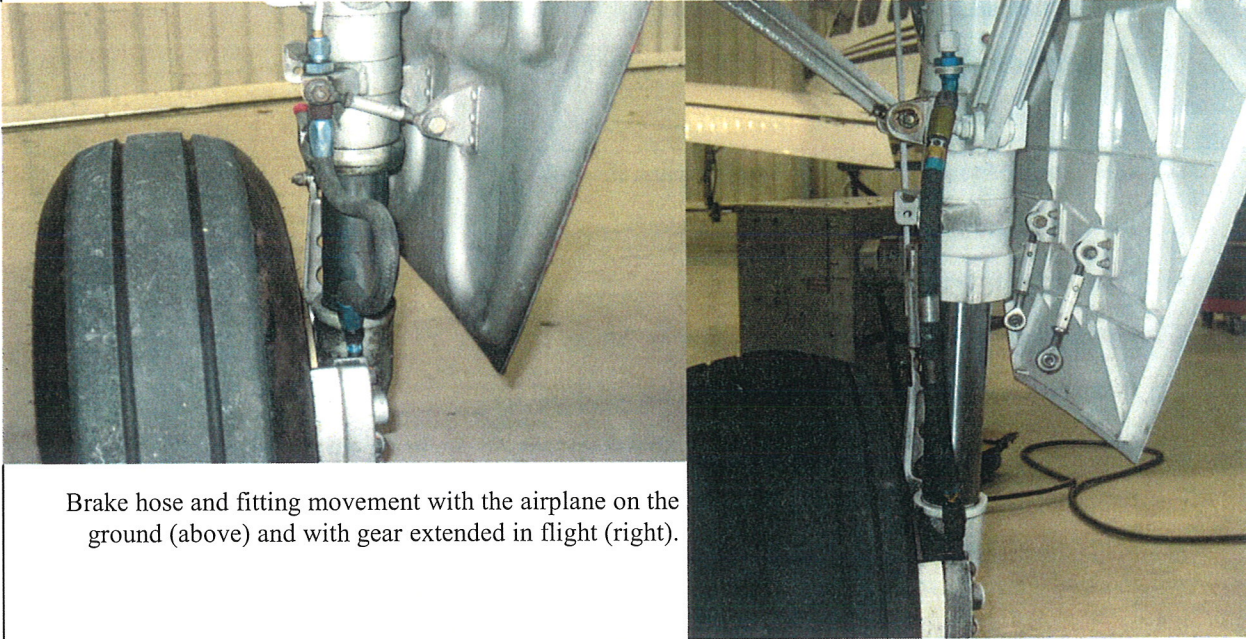
Brake hose and fitting movement with the airplane on the ground (above) and with gear extended in flight (right).

Discrepancy: Brake hoses require replacement and/or installation
