Budget Door Lock Cylinder Solution

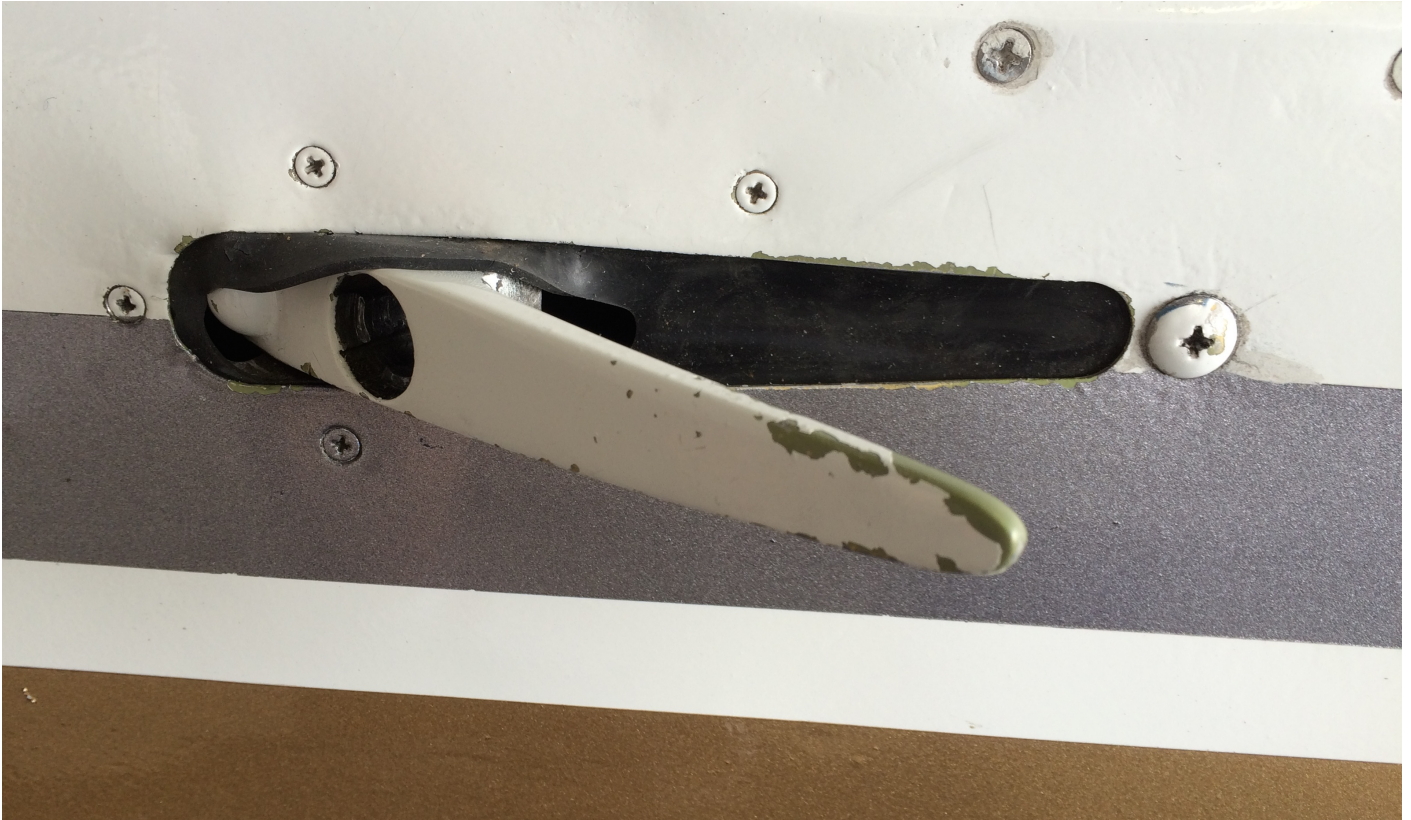
Figure 1

After a nice extended weekend trip in my B55 Baron to Port Aransas, TX (KRAS), I returned to my aircraft and unlocked the cabin door. Upon pulling the latch outward the lock cylinder popped out onto the wing (Figure 1) and I heard the distinct sound of metal parts falling into the door! After a few moments of processing what had just happened, I reasoned that the door latching mechanism was not in any way dependent upon the lock cylinder and its attaching parts. After the minor head scratching delay, the departure and flight back to Denton, TX (KDTO) home base was uneventful.

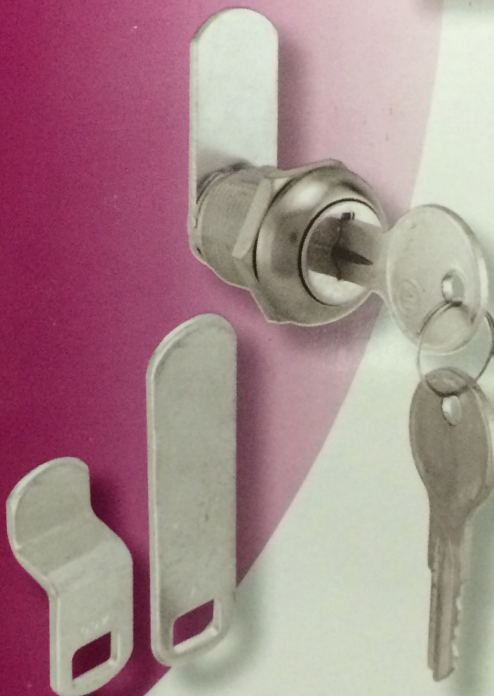
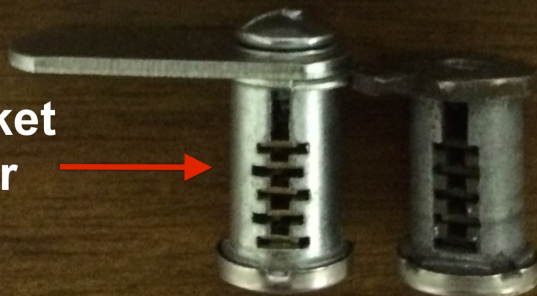
Figure 3

Aftermarket
Cylinder
U-9941

Original
Beech
Cylinder

At Home Depot I was able to find PN: U-9941 (Figure 3), which appeared to be a very close match to the original Beech cylinder. At \$4.59, less than the cost of shipping anything with a 35-XXXXX part number, I took it back to my hangar to see what minor surgery I could perform to put my Humpty Dumpty lock cylinder back together again.

As it turned out, the screw for the U-9941 did not fit the original lock cylinder so now the only solution was to put the U-9941 cylinder into service. After some minor grinding of the U-9941 supplied cam with a cut off air tool and a Dremel to replicate the original cam profile the new cylinder was functioning just as originally designed. The bonus was that I happened to pick up the key number that matched my existing key (Figure 4)! Talk about being amazed. The parts catalog for my B55 list three door lock cylinder PNs: 35-590070-15, -33, and -43. Bonanza door lock cylinder PNs are listed as: 35-590070-3 and 35-590099-5.
