# Interim report

on the accident on **1<sup>st</sup> June 2009**  
to the **Airbus A330-203**  
registered **F-GZCP**  
operated by **Air France**  
**flight AF 447 Rio de Janeiro – Paris**

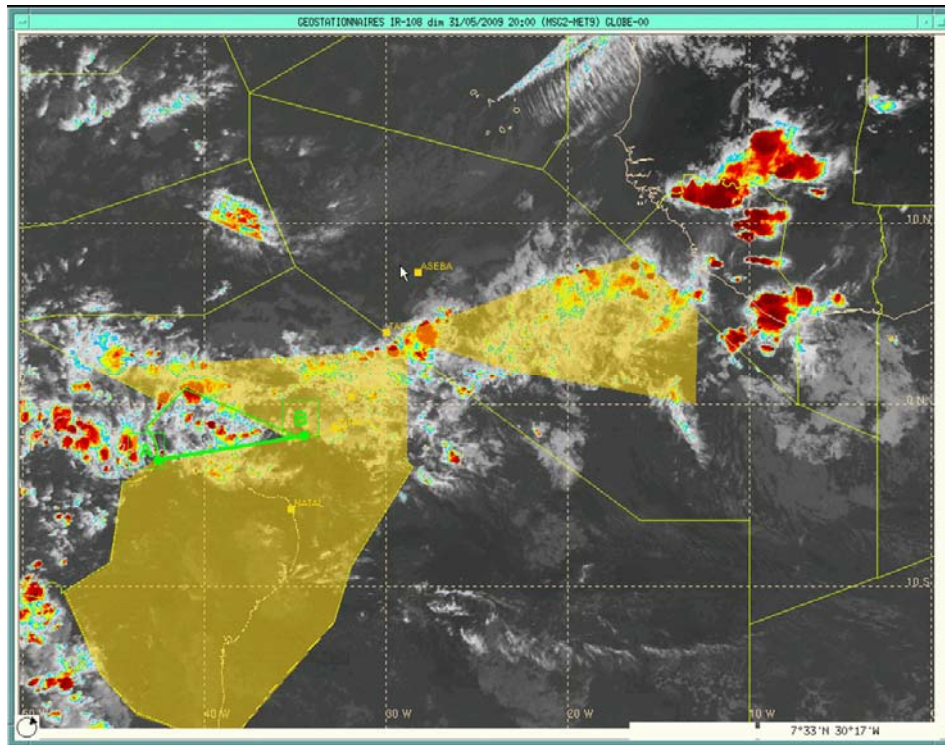
- line AB is in the south-west/north-east direction and yet, in such a case, a "SE OF" or "NE NW OF" mention would be expected, and not "SW OF" as is the case in the SIGMET,
- the satellite images during the period of validity of the SIGMET show the convection zone to be located to the North-West of line AB rather than to the South-East of the same.

It is thus possible that this SIGMET includes an error, with a SW OF mention instead of a NW OF mention. On this assumption, SIGMET 5 SBRE would complete the zone identified in the ATLANTICO FIR, as represented by the green line in the figure below:

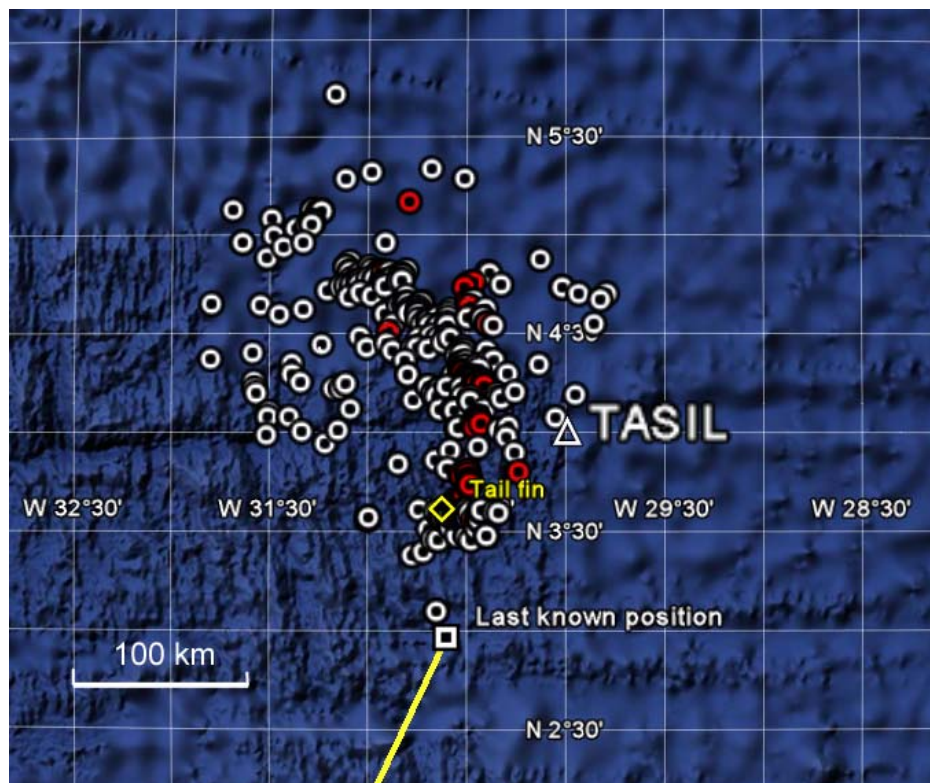
Whenever the information is available, the position, the date and the time of their recovery are indicated. The chart below shows the position of all of the bodies and debris thus geo-referenced. The bodies are represented by red circles and the debris by white circles. The tail fin (vertical stabiliser), found on 7 June is represented by a yellow diamond.
