SPECIAL INVESTIGATION REPORT

DESIGN-INDUCED LANDING GEAR
RETRACTION ACCIDENTS IN
BEECHCRAFT BARON, BONANZA, AND
OTHER LIGHT AIRCRAFT

SIR
NTSB-SR-80-1

Adopted: June 24, 1980

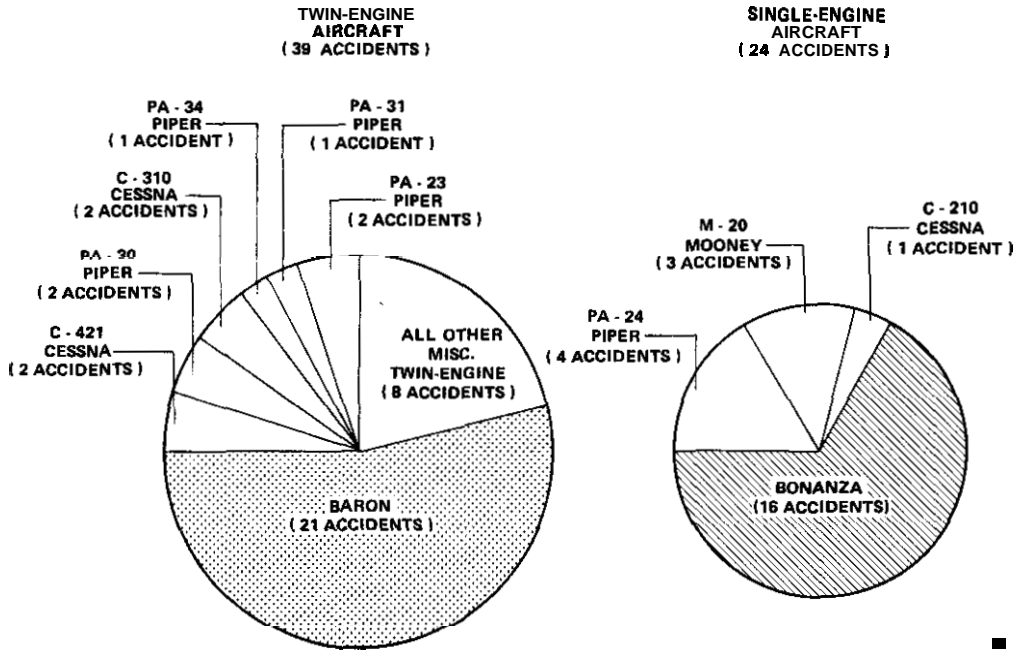
Number and Rate ^{1/} of Inadvertent Landing Gear Retraction Accidents in Popular Light Aircraft ^{2/} 1975 - 1978

^{1/} These rates were derived for each type aircraft by dividing the number of inadvertent landing gear retraction accidents by the estimated number of those aircraft which were active.

^{2/} Aircraft models with more than 500 active aircraft in 1978.

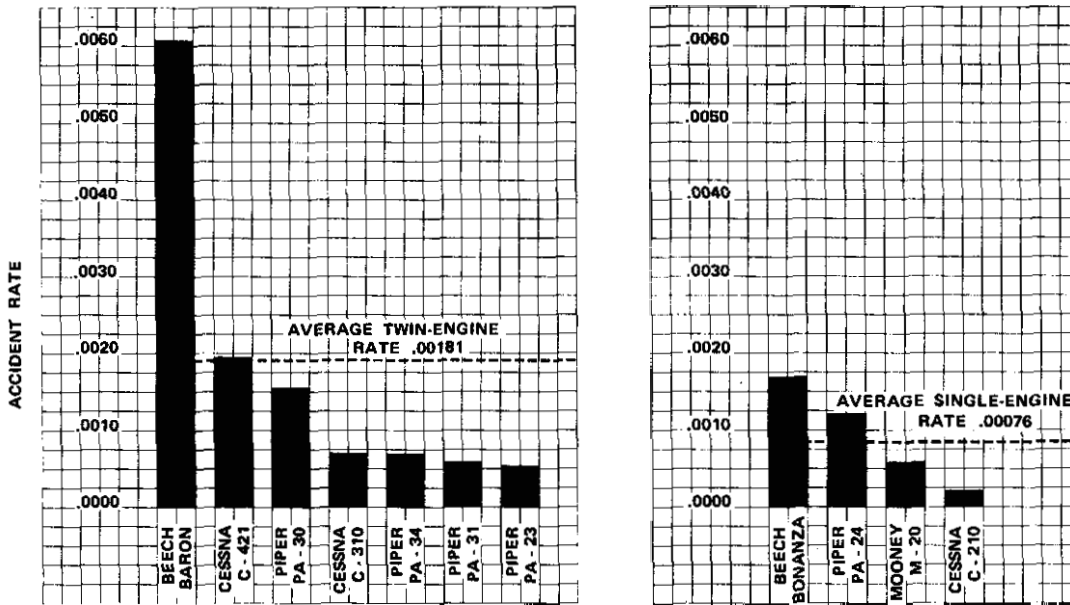
Inadvertent Gear Retraction : Accident Rate Through 1978

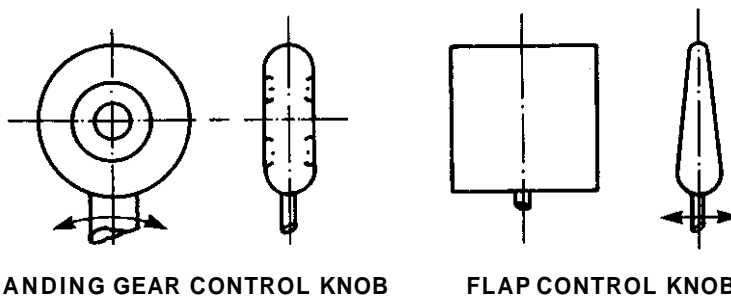
Figure 2.--Currently "required" control knob shapes 14 CFR 23.781.

Regulatory requirements for the location and shape coding of controls were first adopted October 1, 1959, by Amendment 3-5 to the Civil Air Regulations, which revised Section 3.384. These regulations were essentially identical to the current Federal Aviation Regulations adopted in September 28, 1964, which require that the location and shape coding of controls be standardized as follows: 14 CFR 23.777 states: "Wing flap and auxiliary lift device controls must be located--(1) Centrally, or to the right of the pedestal or powerplant throttle control centerline; and (2) Far enough away from the landing gear control to avoid confusion." The landing gear control gear must be located to the left of the throttle centerline or pedestal centerline. Regulation 14 CFR 23.781 states: "Cockpit controls must conform to the general shapes (but not necessarily the exact sizes or specific proportions) in the following figure." (See figure 2.)
