**MIKE BUSCH**

# Cylinder Work: Be Afraid

It is nearly impossible to install a cylinder properly when the engine is on the airplane

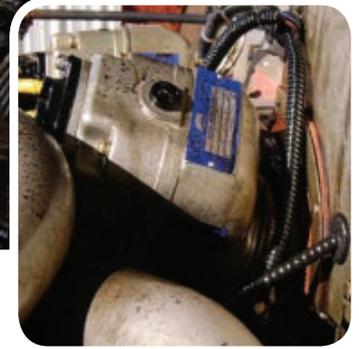
*This Continental IO-550 threw the No. 2 rod through the top of the case less than 10 hours after the No. 2 and No. 4 cylinders were replaced at annual.*
