# **THE TECHNICIANS NOTEBOOK**

**By Jerry Gordon**

## The Technician's Notebook Table of Contents

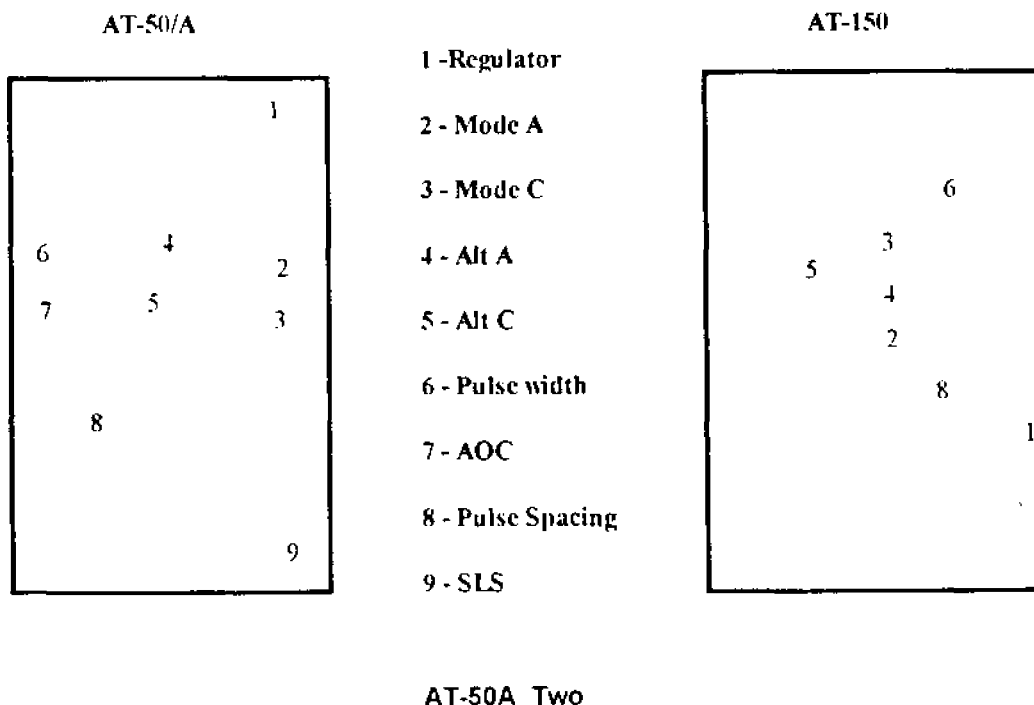
The multi feeding the modulator transistor Q117, (fish-eye) if temperature sensitive can turn the modulator on hard taking the power supply. Q134 goes first before Q133.

The cavity in the AT-50 is too expensive to repair. Replace the transponder if the cavity is bad.

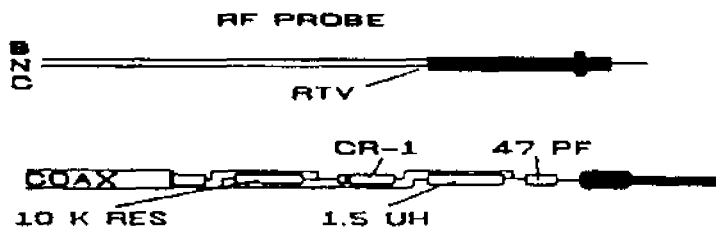
Parts list for RF probe, (See drawing).

1. The 4 ft of coax is the filter capacitor to provide DC to the 1 meg input to a scope.
2. The probe is necessary for working on the transmitter.
3. This probe will work from the synthesizer output through the multiplier, through the power amplifier, and to the collector of the output transistor.
4. Note the probe will crater if used in the output of the VHF-251 & VHF-253, but will work to the input of the base of the output transistor in the VHF-251 & VHF-253.
5. Do not use it at the output of the TDR-950.
6. For unmodulated RF, the probe will provide a dc output proportional to the amplitude of the RF. For modulated RF the output will be a representation of the modulation changes.

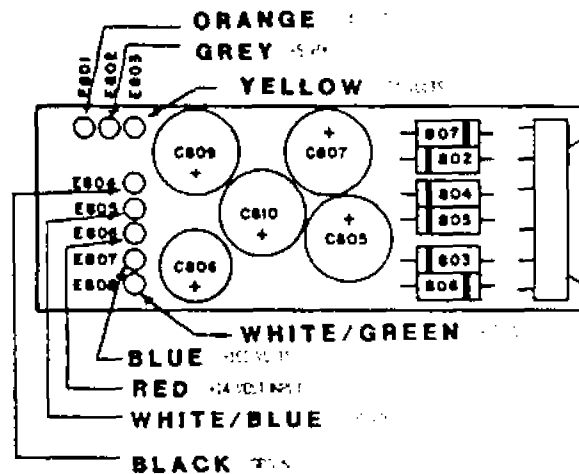
DME-890 One

**Transmitter problems:** Resolder areas of transmitter board around Q-101 and Q-103 and the variable caps. If you have distortion on the transmitter waveform, check for noise on the 14 volt line and replace the filter cap if necessary. (C-807)

**Display problems:** Some digits are lit brighter than others. Replace C-323. If you see some legends flashing dimly, trying to light, check for fuzz on the + 100 volt and -100 volt lines. If you have noise there replace C-805 and C-810.

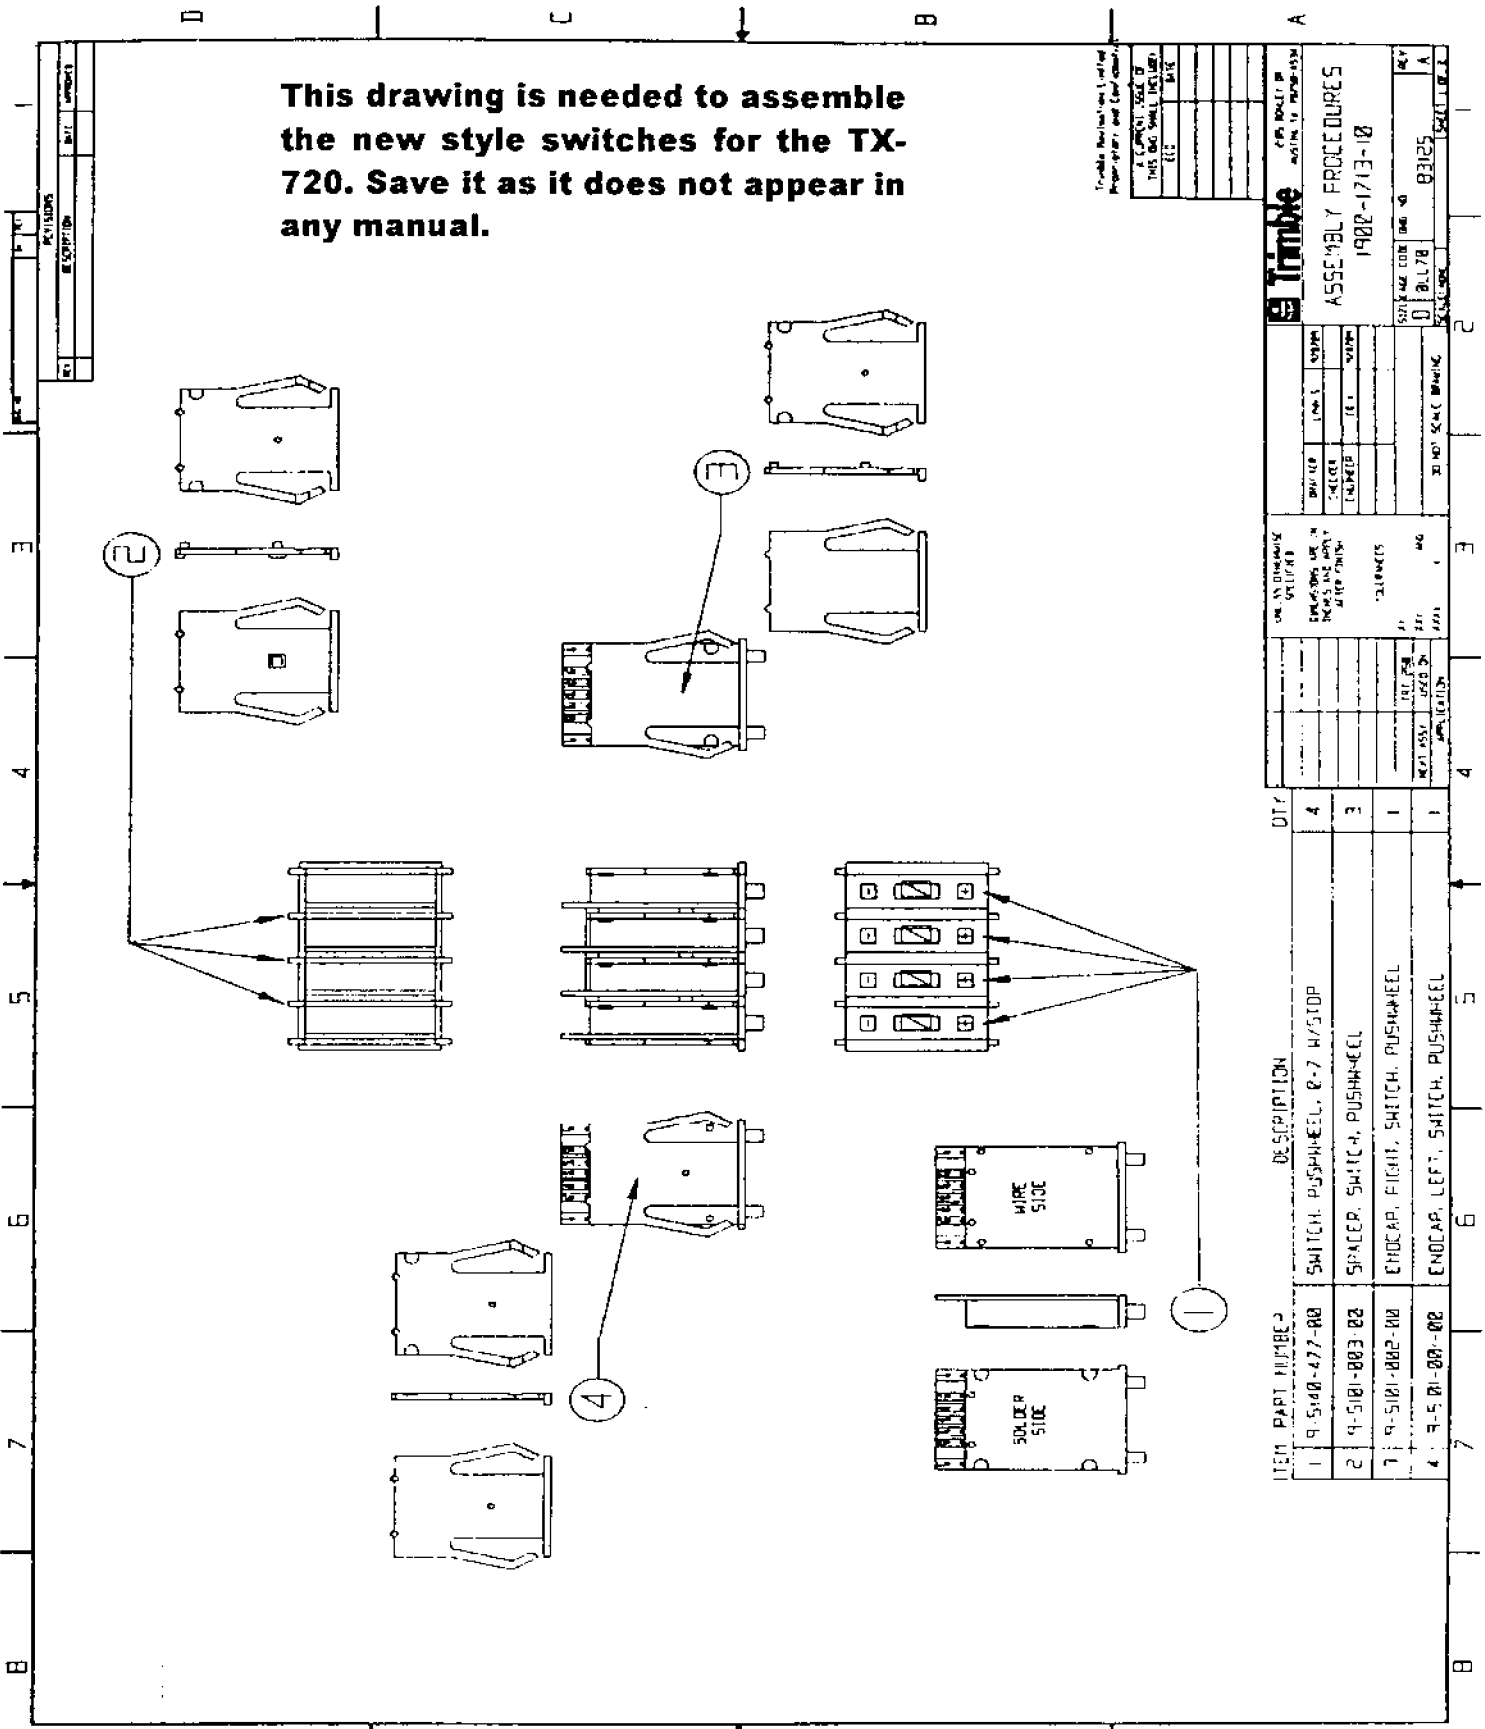
This drawing is needed to assemble the new style switches for the TX-720. Save it as it does not appear in any manual.
